# Withstanding the pressure: liners for pressure sewers put to the test

Aging pressure sewer pipes, just like gravity sewers, require renovation. But which methods are best suited for the job? What are the pros and cons of each? The latest IKT comparative product test on pressure sewer liners offers valuable insights.

## Table of results IKT comparative product test “Renovation of sewage pressure pipes”

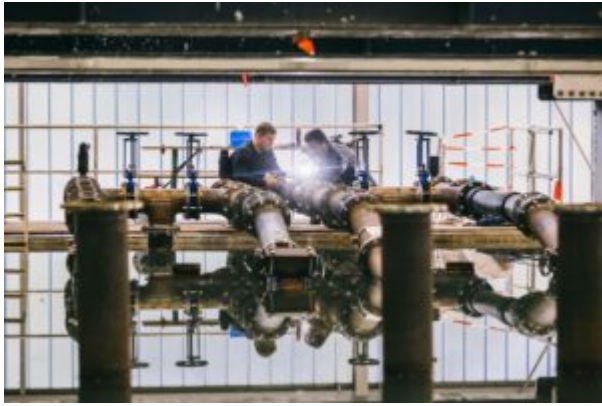
e Simulation of external water pressure: After flooding, part  
co of the test setup is reflected in the water

The SaniPipe liner failed this criterion as it collapsed under external pressure. The reason for this was insufficient fabrication of the liner, which took place without static proof. It was therefore not a Class A liner and consequently received the overall rating INADEQUATE, regardless of performance against all other criteria.
