Coatings for a water-tight manhole shaft

IKT Comparative Test „Manhole Rehabilitation“

IKT Comparative Test „Manhole rehabilitation“: Test results

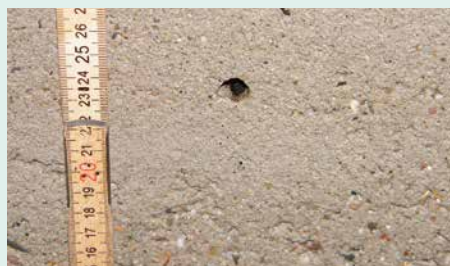
Isolated damage: every manhole was subjected to „pre-damage“ in the form of eight drilled holes (dia.: 10 mm).

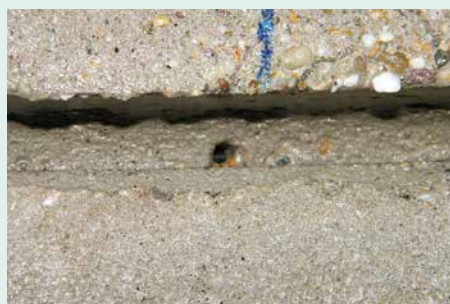
Five leaking ring joints per manhole: four drilled holes of 6 mm dia. per joint

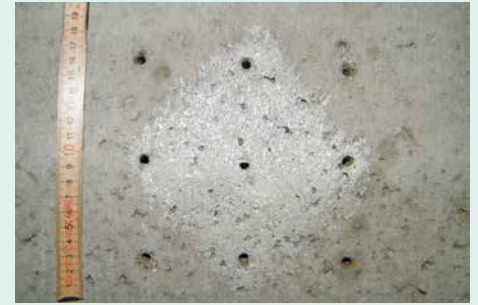
Area damage: nine drilled holes of 5 mm dia. in an area of 20 x 20 cm and application of mould release agent to a small area

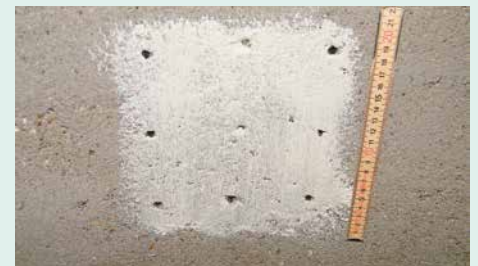
Area damage: nine drilled holes of 5 mm dia. in an area of 20 x 20 cm, application of mould release agent to a large area

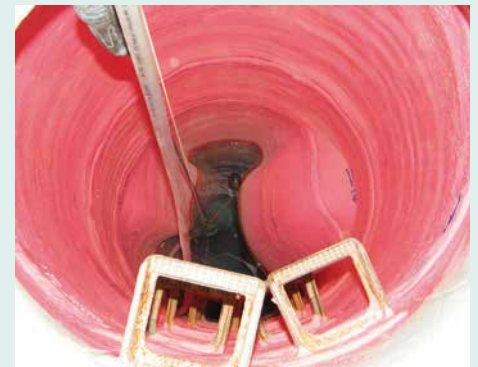
Due to a system failure caused by the „pre-damage“ areas (mould release agent applied to assess „robustness“), it was not possible to

System failure: It was not possible to evaluate the „Spectrashield“ system.

evaluate the „Spectrashield“ system. It was no longer possible to enter the manhole.

One of the coating systems could not be evaluated, since it proved to be extremely sensitive to isolated deficiencies in substrate preparation (test criterion „robustness“). Giant bubbles, which prevented renewed entry to the manhole, developed under exposure to external water pressure, starting from the local weak points where mould release agent had been applied for the test. Other systems exhibited cracking, blistering, hollow point enlargements and leaks at such points.

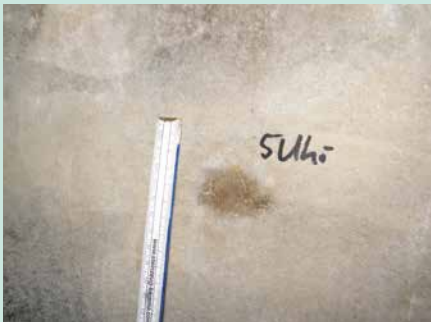
Damp patch smaller than 25 cm

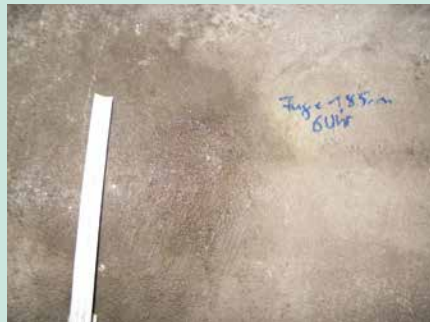
Damp patch larger than 25 cm

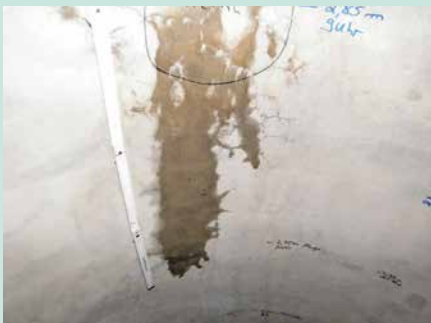
Damp patch with spreading plume

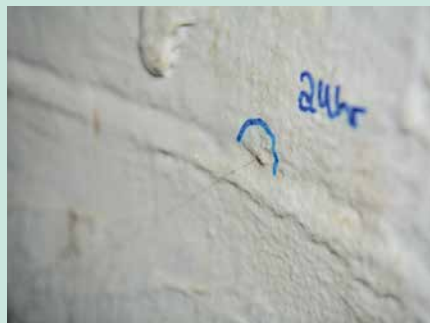
Infiltration

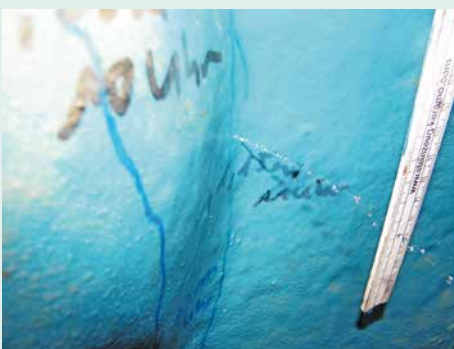
Deficiencies in substrate preparation: blisters and cracks may be the result if the mould release agent prevents secure bonding.

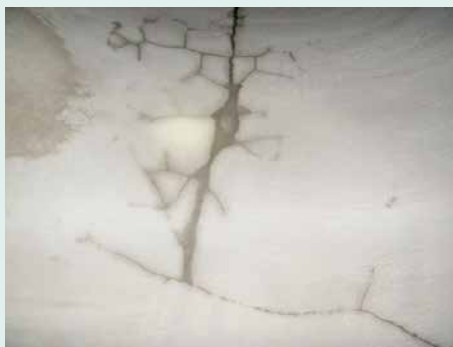
Cracks are indicative of an inadequate adhesive bond with the substrate.

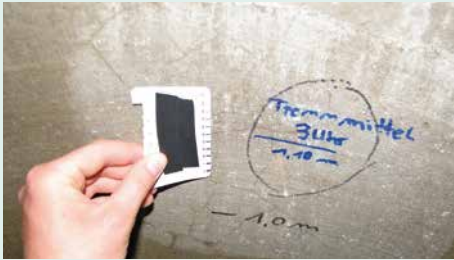
Cracking in a zone pre-treated with mould release agent.
