IKT Comparative Product-Test of repair methods for lateral connections

Do repaired lateral connections remain permanently watertight against infiltration? How do contractors, machinery and materials perform in practical tests? The results: varied right across the board, from VERY GOOD to DEFICIENT ...

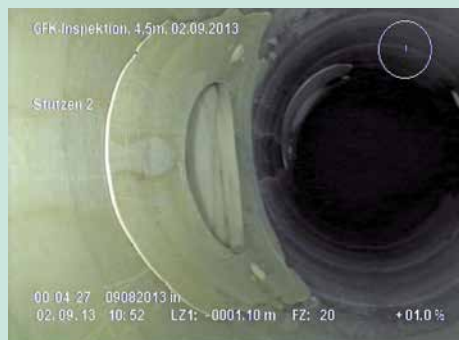
A: Tight lateral connection in the GRP lined pipe

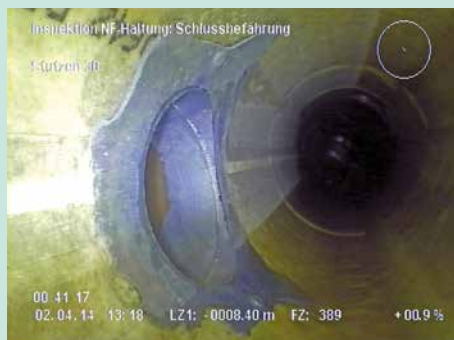
B: Tight lateral connection in the NF lined pipe

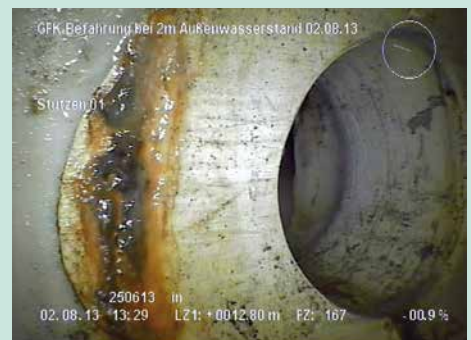
C: Discoloration

Five of the thirty-four lateral connections (approx. 15 %) exhibited abnormalities in the form of discoloration or moisture; and continued observation of these lateral connections would appear recommendable in practice. It should be noted, however, that HP cleaning is capable of removing these marks and that these abnormalities are then no longer perceptible. However, no waste-water was being fed through the test apparatus and in reality this may cause significant discoloration to the liner and the rehabilitated lateral connection, complicating or preventing identification of infiltration-induced abnormalities.

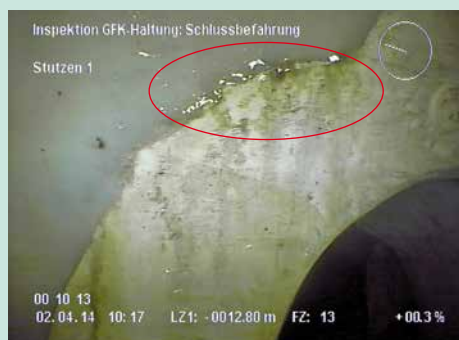
D: Moisture, with no infiltration

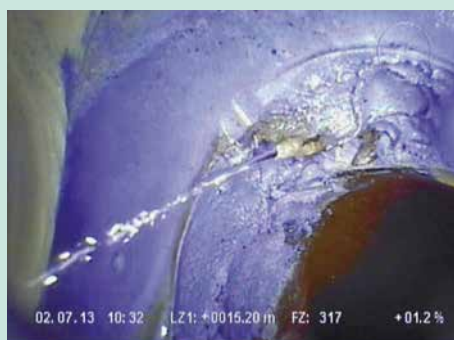
E: Leaking lateral connection (jet of water)

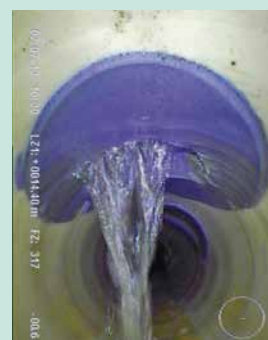
F: Leaking lateral connection (gushing water)

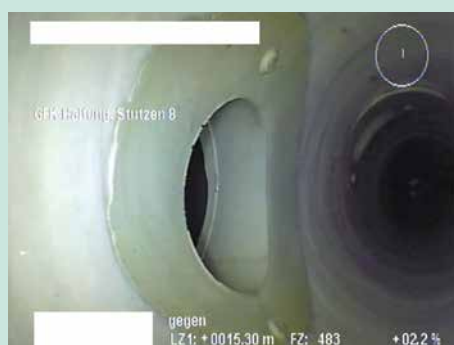
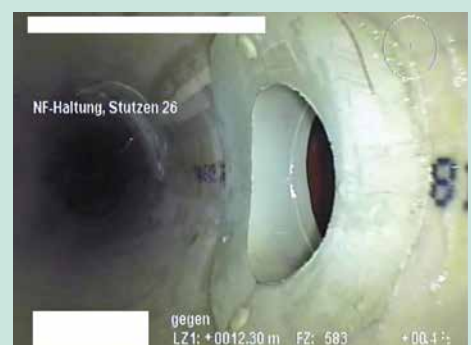
Figure 4: The best-graded lateral connection for the „Functionality“ criterion, in each case after HP cleaning; GRP lined pipe (left); NF lined pipe (right)

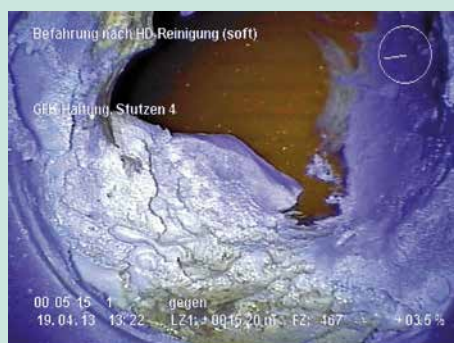
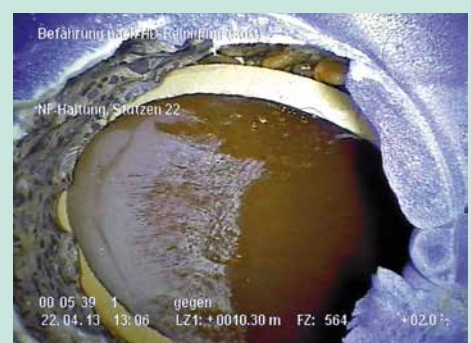
Figure 5: Poorest-graded lateral connection for the „Functionality“ criterion, in each case after HP cleaning; GRP lined pipe (left); NF lined pipe (right)

Only minimal variations in grades, by a maximum of 0.3 points, were apparent after HP cleaning. It is notable that only slight visual abnormalities, in the form of spalling of material at the repaired lateral connections, occurred as a result of cleaning. This was observed more frequently in the NF lined pipe (13 of 18 lateral connections). Spalling was apparent only on two of eighteen lateral connections in the GRP lined pipe. Such spalling is generally harmless in terms of sewer functionality.

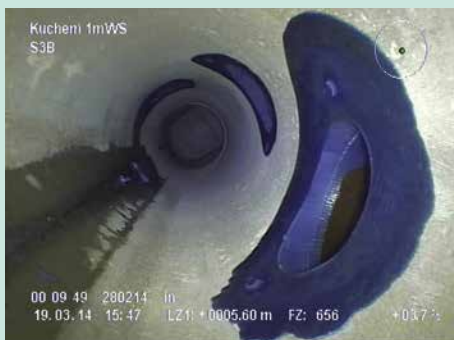
A: Tight lateral connection in concrete pipe

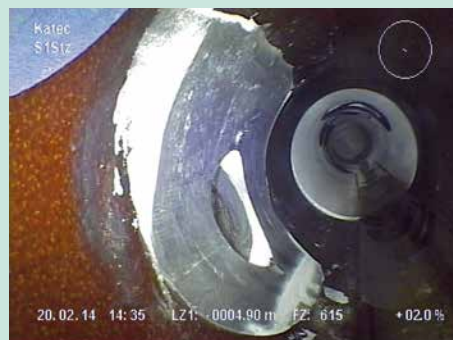
B: Tight lateral connection in vitrified-clay pipe

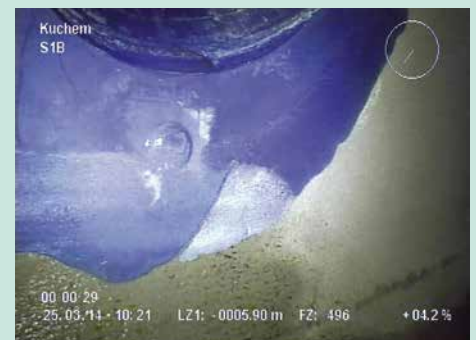
C: Moisture, with no infiltration, Example 1

Five of the thirty-six lateral connections (approx. 14 %) exhibited abnormalities in the form of moisture. A risk is therefore present here and further observation of these lateral connections would appear advisable in practice.

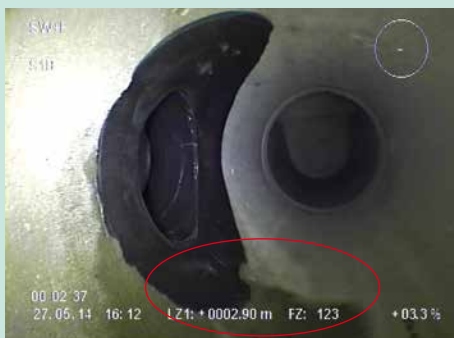
D: Moisture, with no infiltration, Example 2

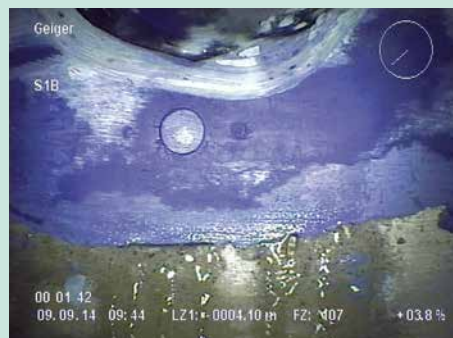
E: Leaking lateral connection in concrete pipe

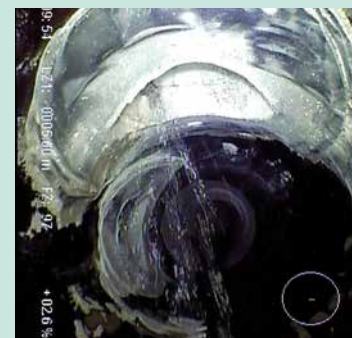
F: Leaking lateral connection in vitrified-clay pipe

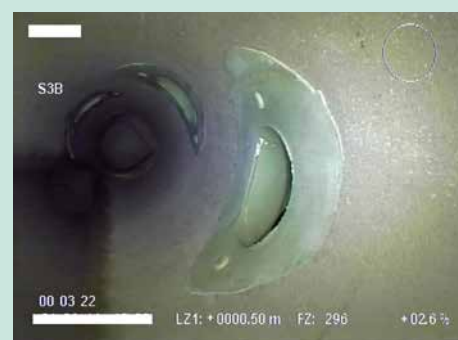
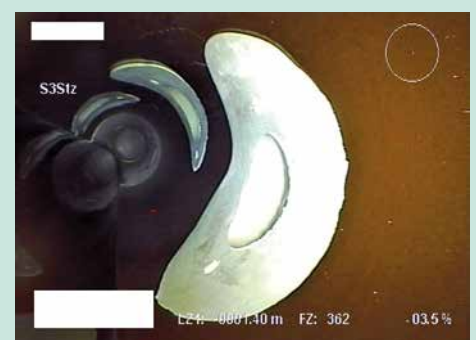
Figure 7: The best-graded lateral connection for the „Functionality“ criterion, after HP cleaning in each case; concrete pipe (left); vitrified-clay pipe (right)

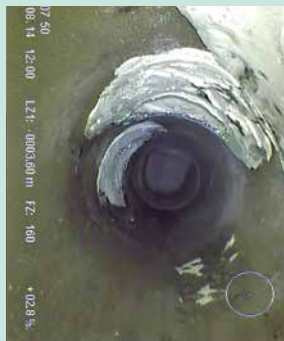
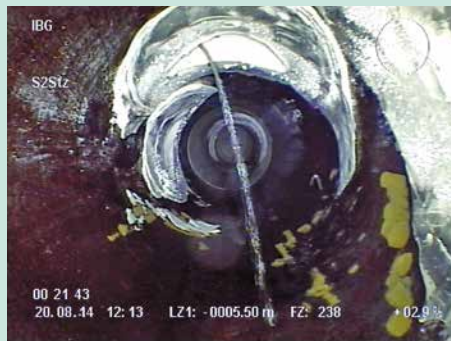
Figure 8: The poorest-graded lateral connection for the „Functionality“ criterion, after HP cleaning in each case; concrete pipe (left); vitrified-clay pipe (right)
