# IKT-Comparative Product Test

## Rehabilitation methods for wastewater pressure pipes - Class A liners -

Gelsenkirchen, November 2022

## **IKT-Comparative Product Test Report:**

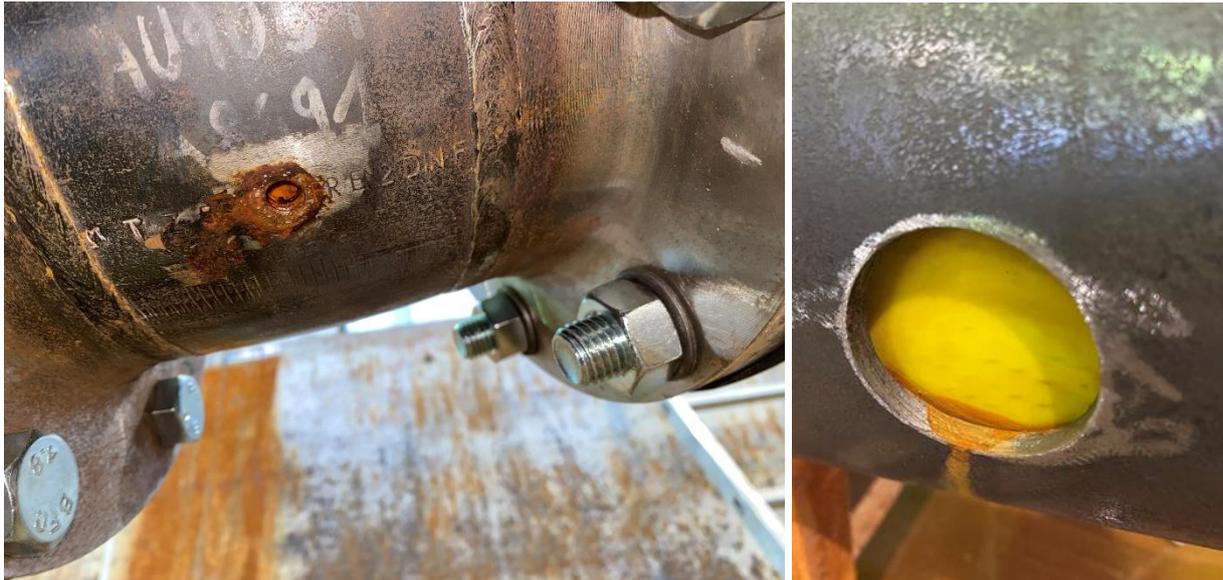
Figure 14 Exfiltration watertightness: Moisture on the "SaniPipe".

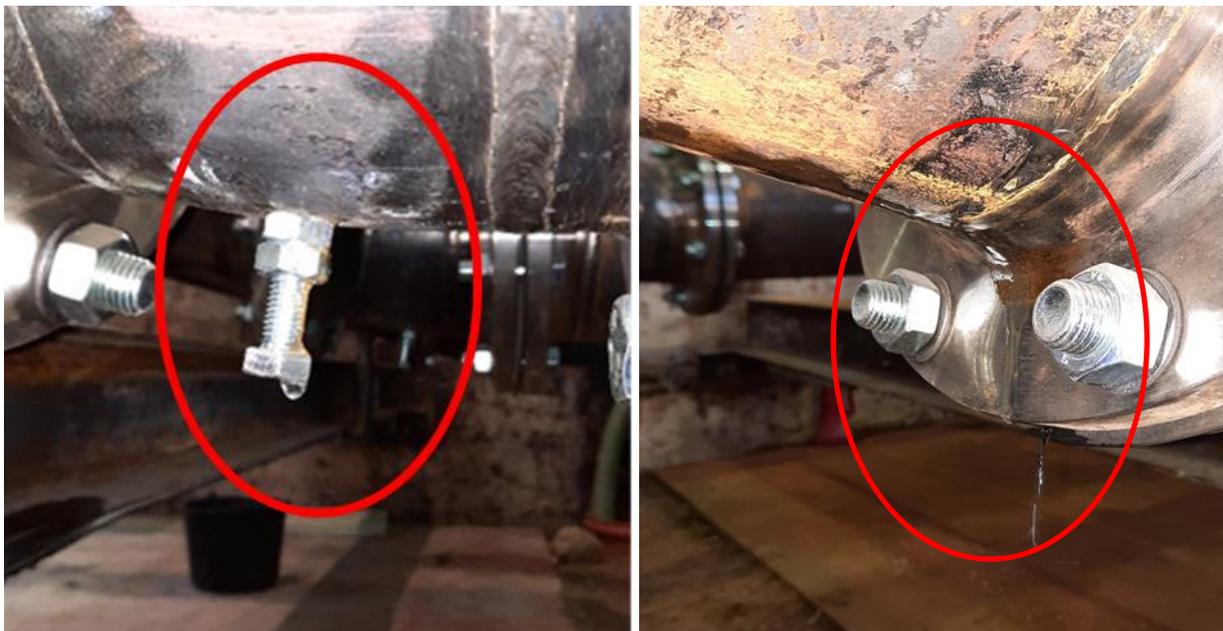
Figure 15. Exfiltration watertightness: Drops on the "Esders HPS Liner".

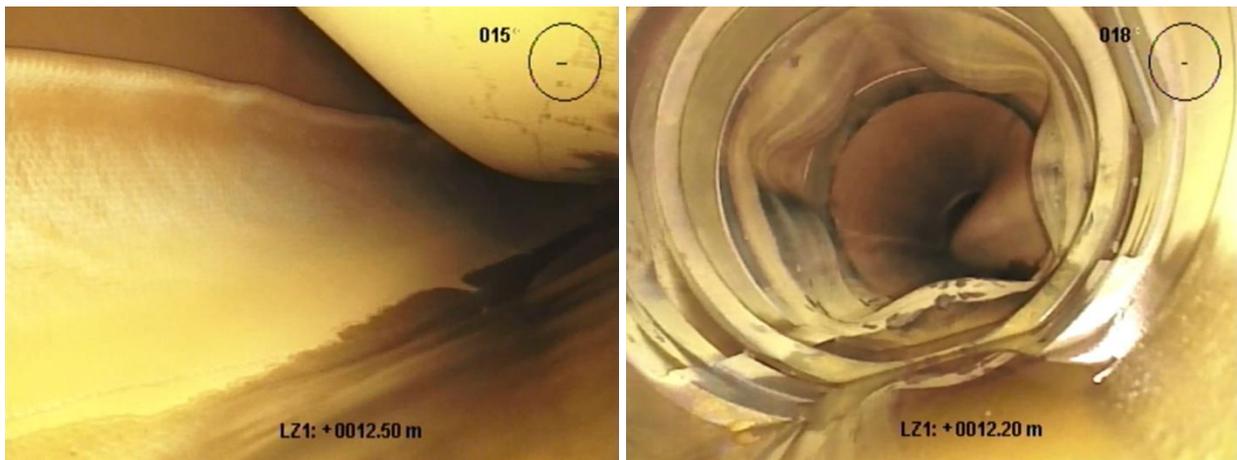
Figure 20. Load-bearing capacity of the "SaniPipe" structure: collapse due to negative air pressure and external water pressure loading.

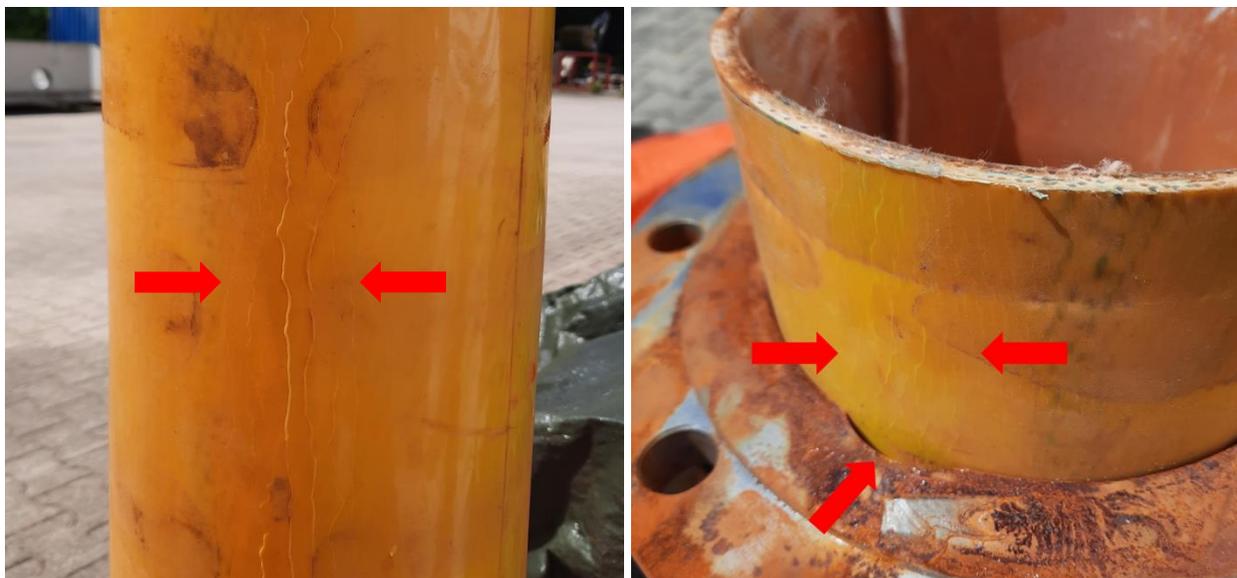
Figure 21. Load-bearing capacity of the "SaniPipe" structure: cracks due to collapse caused by negative air pressure and external water pressure loading.

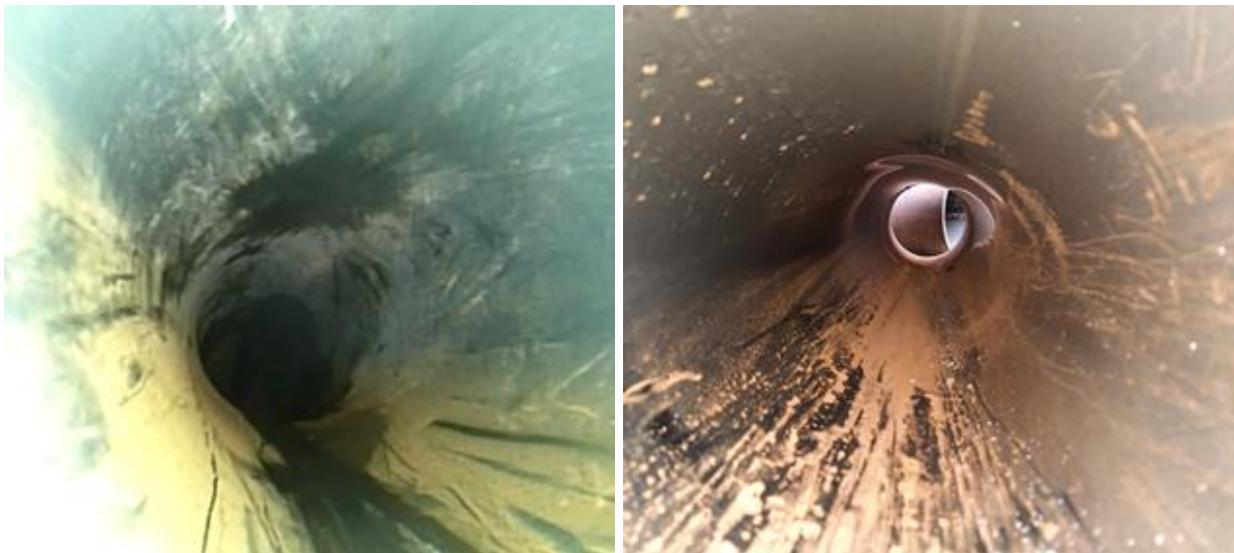
Figure 22. Overall visual impression: Compact Pipe without conspicuous anomalies (left), egeLiner without conspicuous anomalies (right).

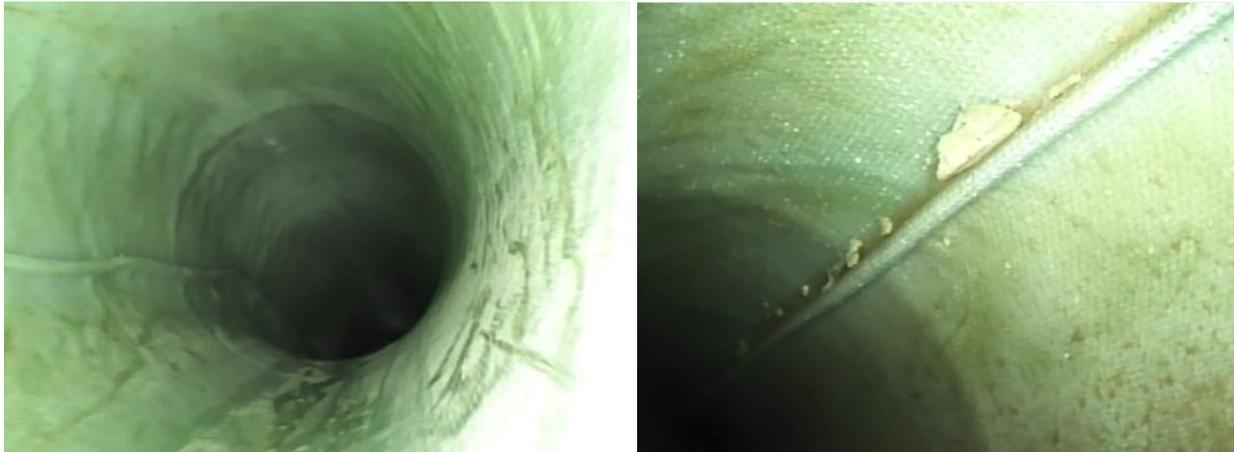
- With "Esders HPS-Liner" there was a possible risk of failure of the system because there was a continuous longitudinal fold in the liner, so it was graded 5.0. In the case of the "SaniPipe" system, a continuous longitudinal fold in the liner and a collapse in the course of the negative air pressure and external water pressure load, and so a grade 6.0 was awarded. Due to this collapse, the Steering Committee decided for the knock-out criterion of "load-bearing capacity of the structure" that this system was "not usable as a Class A liner". Accordingly, the overall test rating "inadequate (6.0)" was awarded, independently of the grades achieved for other criteria.

Figure 23. Overall visual impression "Esders HPS Liner": continuous longitudinal fold (left), deposits on continuous longitudinal fold (right).

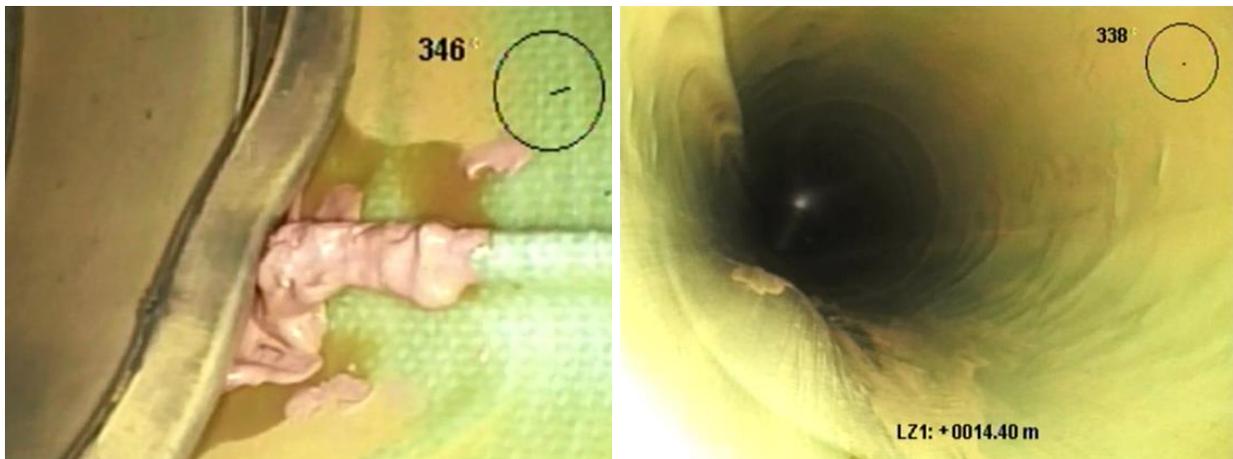
Figure 24. Overall visual impression "Esders HPS Liner": resin seal in the fold area at connection 3 (left), bulge in the liner (right).

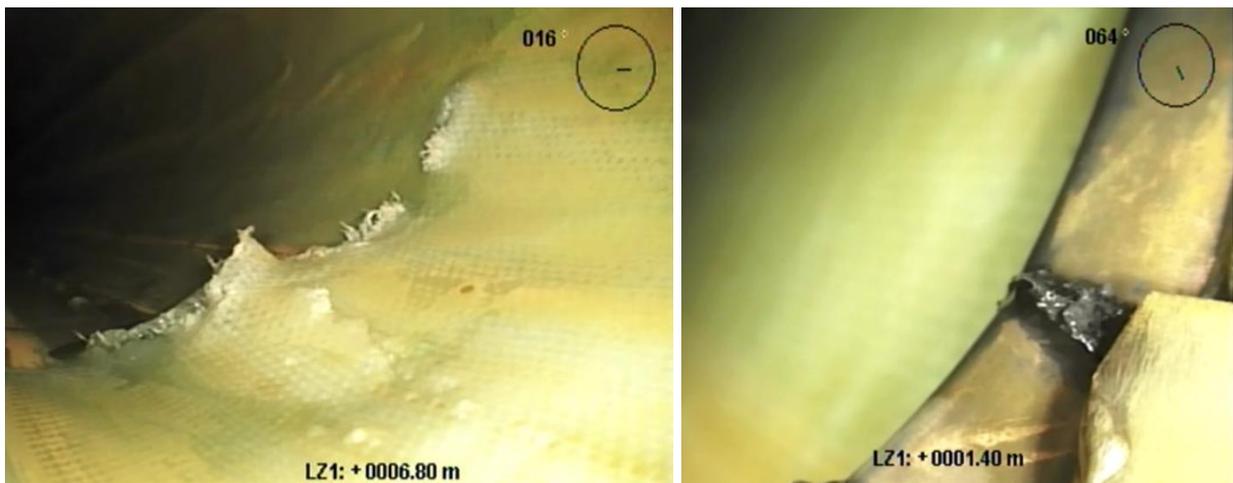
Figure 25. Overall visual impression of "Esders HPS Liner": holes after HP cleaning (left), holes in the rubber of the sleeves after HP cleaning (right).

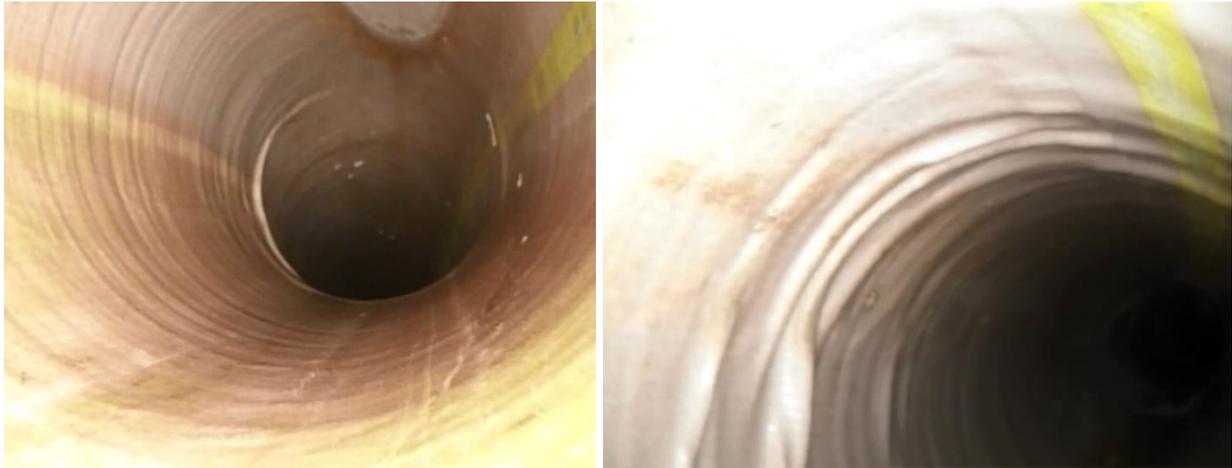
Figure 26. Overall visual impression "Nordiflow W PE": No conspicuous features (left), wrinkles in a bend (right).

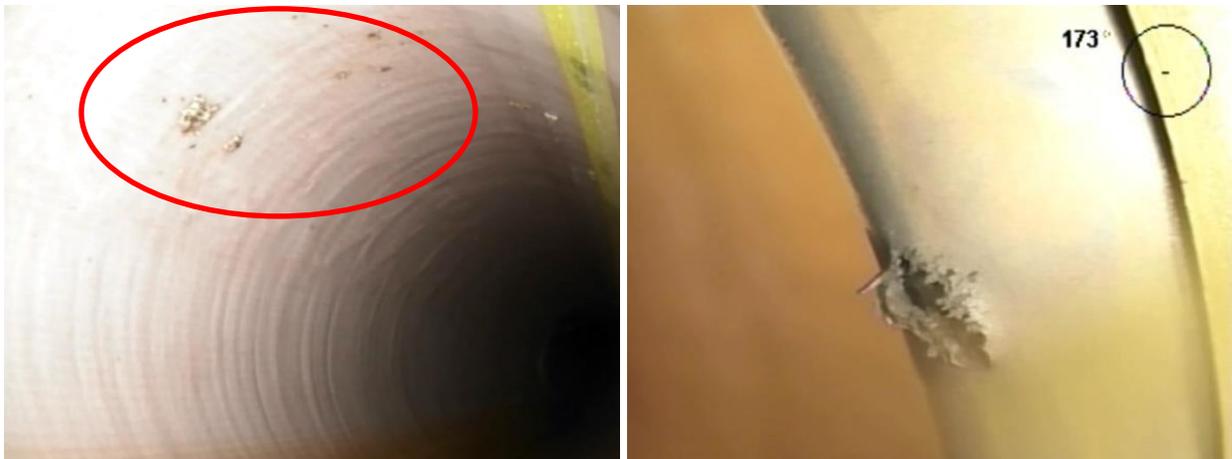
Figure 27. Overall visual impression "Nordiflow W PE": deposits (left), hole in the rubber of an end connection after high pressure cleaning (right).

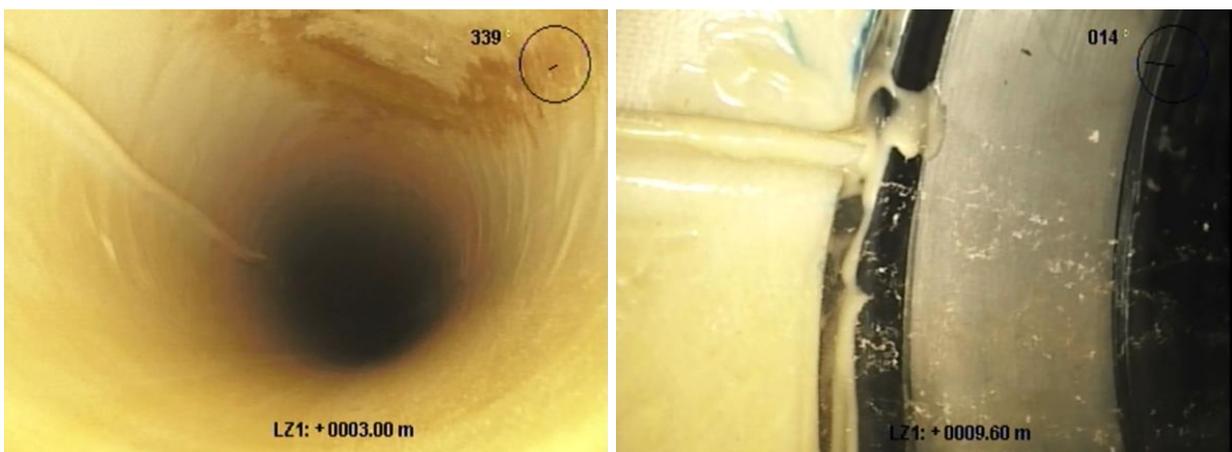
Image 28. Overall visual impression of "SaniPipe": continuous longitudinal fold (left), silicone seal in the fold area at connection 3 (right).

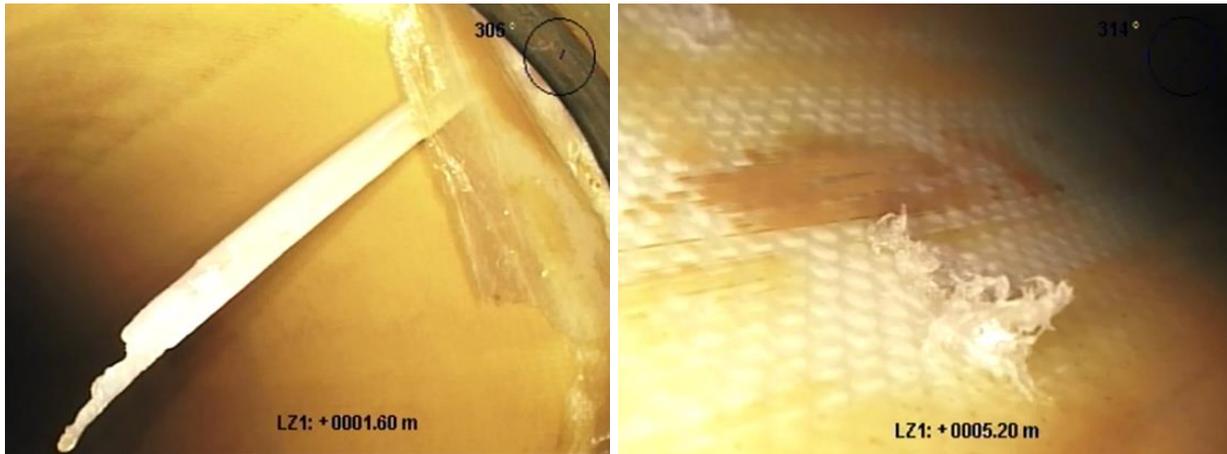
Figure 29. Overall visual impression of "SaniPipe": Damage to end connection after HP cleaning (left), holes in liner after HP cleaning (right).

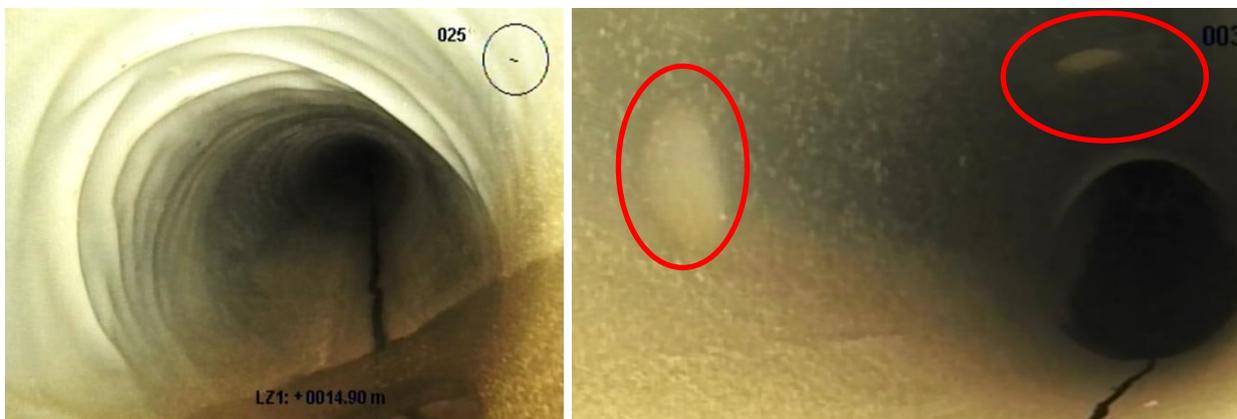
Figure 30. Overall visual impression "Starline Structure-S": wrinkles on a bend (left), discolouration (right).

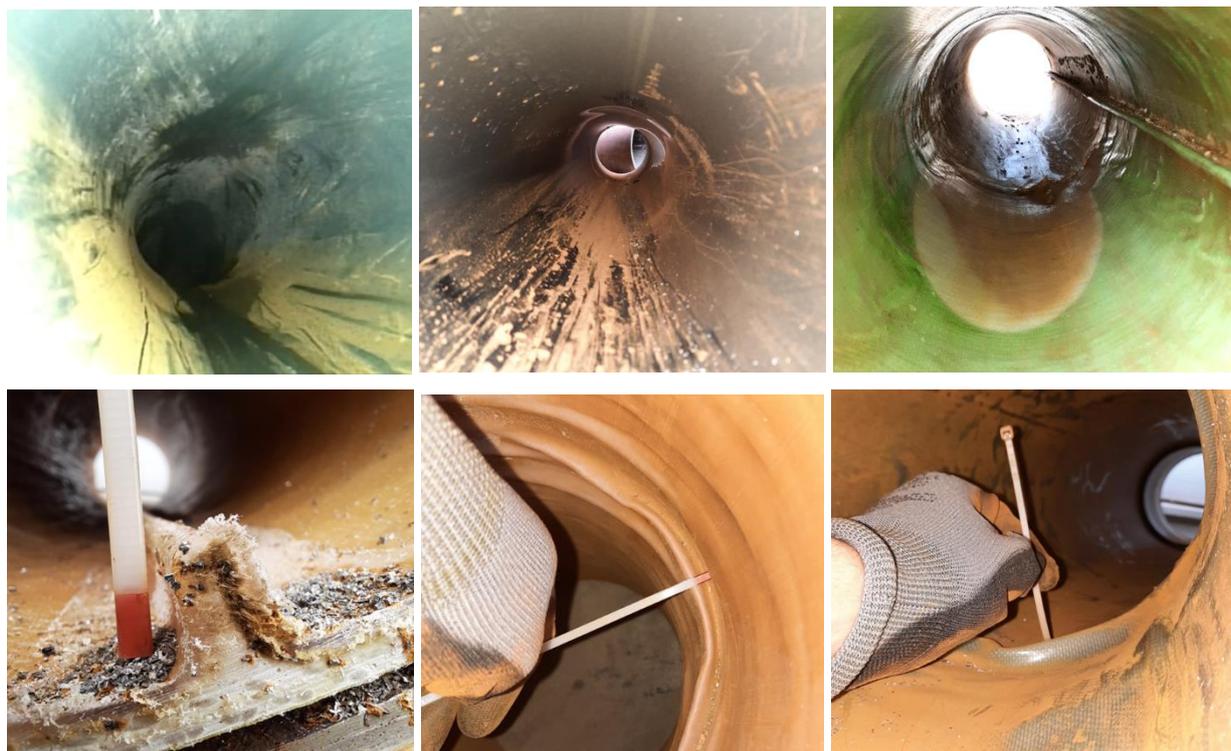
Figure 31. "Wrinkles/obstacles": no conspicuous features with "Compact Pipe" (top left) and "egeLiner" (top centre); longitudinal fold > 6 mm in "Esders HPS Liner" (top right) and "SaniPipe" (bottom left); folds > 6 mm in "Nordiflow W PE" (bottom centre) and "Starline Structure-S" (bottom right).
