# IKT Compare: Can Short Liners Repair House Connections?

How do short liners perform? IKT figured it out in its latest IKT Compare project.

**Short liners** are often the first choice for **repairing local damage** in house connections. But, can they deal with **seriously damaged pipes**? The results of the new **IKT-Compare project "Short Liner for House Connections"** are now available.

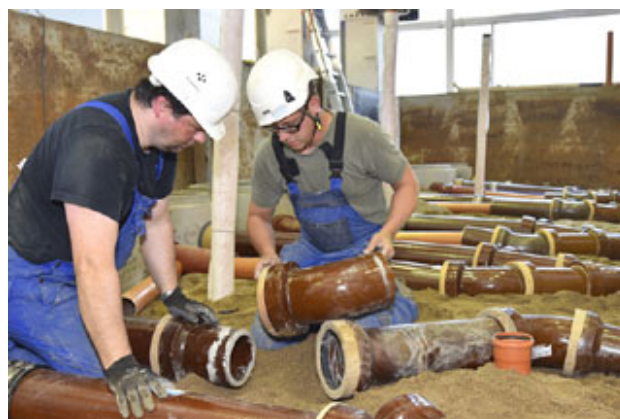
Deliberate defects: IKT has installed eight test sections with a total of 64 cases of damages in its large test pit.

For this project IKT built eight identical **1:1 scale rigs**, in its large-scale test pit (15m by 6m by 6m), into which suppliers installed their short liners. Each rig comprised a

length of sewer to which were attached one **house connection pipe** on the same level as the sewer pipe and two house connection pipes from a higher level. The house connection pipes were prepared with **defined areas of damage**, including milled patterns of **cracks**, the removal of some or all of the **joint seals** and **broken sections**. A total of **64 damage patterns** were produced – eight in each of the eight test rig setups.

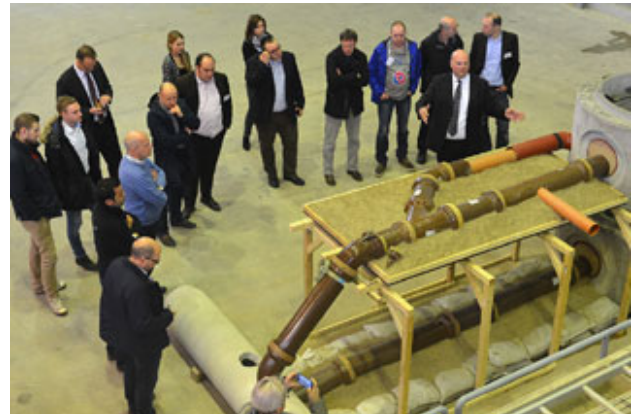
Two up, one down: the test set-up.

These **patterns of damage** were arranged as follows:

- **Test Setup I** (the lower house connection pipe, to which a 2m head of external groundwater was subsequently applied): cracks, a broken joint, a radially displaced joint and a joint displaced at an angle
- **Test Setup II** (the two higher house connection pipes, to which a 1m head of groundwater pressure was subsequently applied): a defective change of pipe material, defective change of pipe diameter and material from cast iron DN 150 to PVC DN 125, a defective change of pipe diameter and material from clay pipe DN 150 to PVC DN 125, and a break in the joint of a 45 degree bend

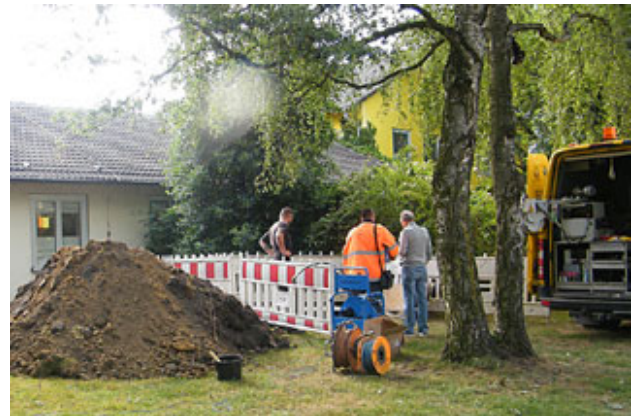
In-situ tests: lab tests were validated through in-situ observation of the same systems being installed at actual construction sites.

In addition to physical tests, the **QA/QC procedures** were examined. The laboratory results were validated through **in-situ observation** of the same systems being installed at actual construction sites. The **final scores** in this IKT Compare test are based on these three evaluations. The **range of grades** applied is from VERY GOOD (score of 1.0) to INSUFFICIENT (score of 6.0).

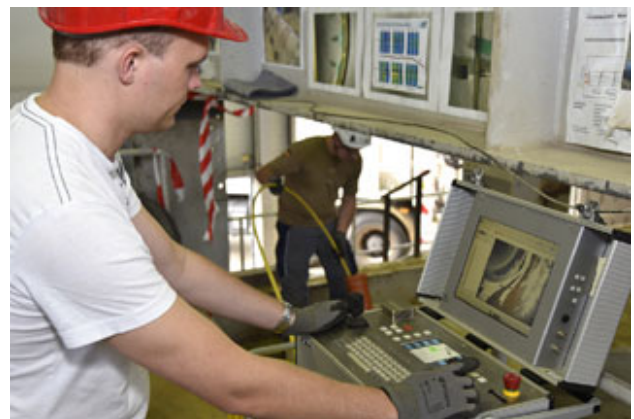
Ongoing observation. IKT testers regularly check the installed short liners for leaks.

Frequent visual inspections and leak tests were undertaken as the programme progressed. Finally, when the test rigs were exhumed from the test-pit, the **cross-section reduction** was measured and the **adhesive tensile strength** and **ring stiffness** of the installed liners were assessed.

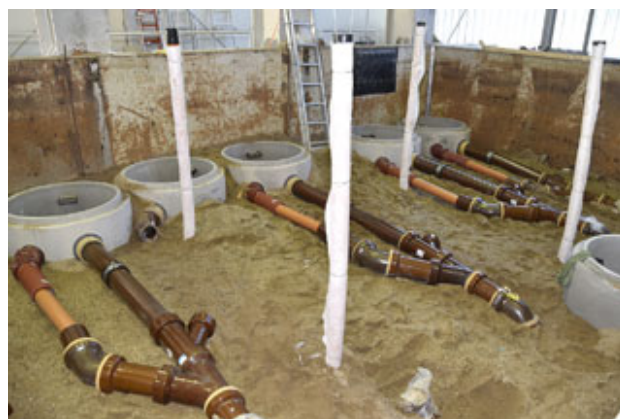
Repair objective: to seal damaged house connections.

In this IKT Compare project, the system suppliers demonstrated that **serious damage** to house connections can be **reliably sealed** using short liners, including breaks, cracks, misalignments and deflections. In particular, the **Twinbond** and **Trelleborg** systems proved to be the **most reliable** under permanent groundwater load, jetting, simulated backflow events and changing groundwater levels. For this they were deservedly awarded the **score of 1.0** for water tightness.

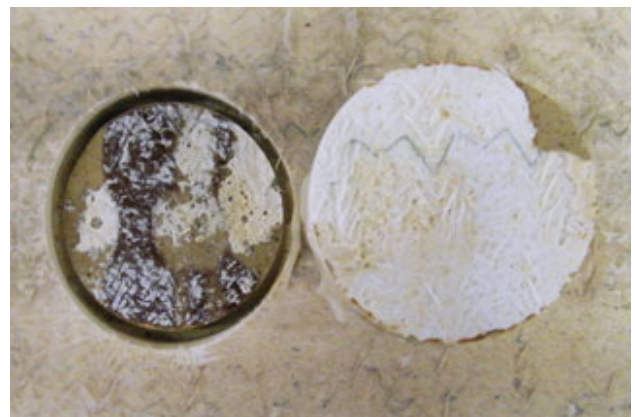
Adhesion test

The structural stability testing of the short liners showed that they basically have **reliable adhesive and load-bearing performance**. For products with full-surface bonding of the liner to the host pipe, hardly any abnormalities were observed, i.e. no crack formation, no excessive deformation,

no stability failure nor large-surface loosening of the adhesive bond. Five systems showed **partial loosening** of the adhesive bond at points of changing diameter or pipe material, albeit without any consequences.

The Cosmic system is not intended to bond over the full-surface, only at the start and end of the liner. However, the supplier was able to submit a **static proof** which confirmed the structural stability of the short liner observed in the test.

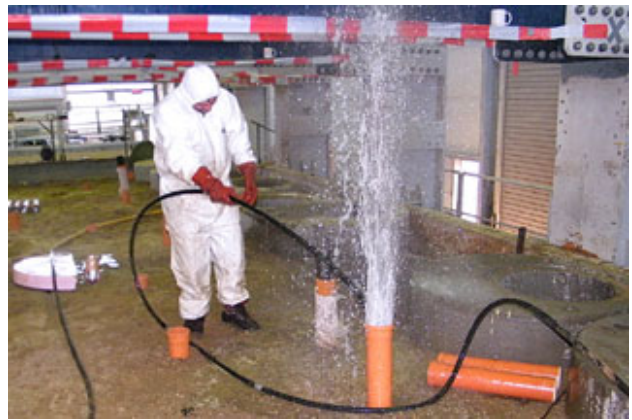
High-pressure jetting did not affect the short liners.

The test scenarios **simulating sewer operation**, such as high-pressure jetting, water backing-up in the pipe, and changing groundwater levels, had **no significant effects** on system performances.

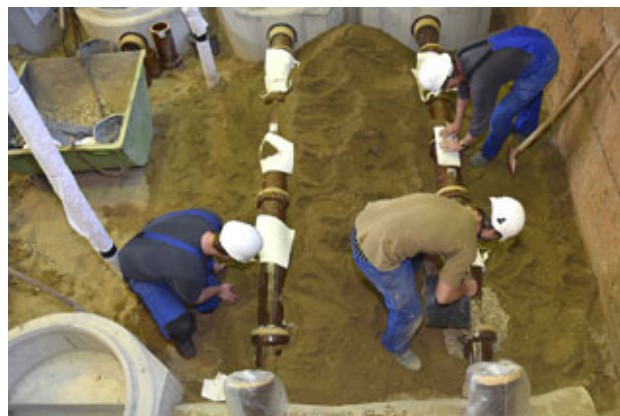
Defined damages: preparing the test rigs
