# Why have we made a bigger hole in the floor of our laboratory?

IKT's Large Test Facility – as originally designed for pipe jacking

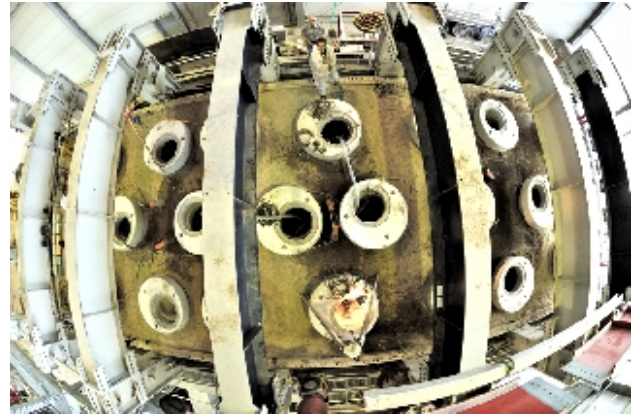
Many manholes buried in the Large Test Facility

**13 manholes with simulated damage** were installed into the Large Test Facility into which different products that are representative of available **rehabilitation technologies** were installed. The experiment also included one new plastic manhole to examine whether it would float out as groundwater rose.

It was proven that it is **possible to seal** against ground water, but results were variable across the range of technologies. There was one **complete failure** of a product against groundwater pressure and various damages/imperfections observed in others. The vital necessity for **good substrate preparation** for products that bond to the wall and advice to wait until groundwater has risen before undertaking acceptance inspections were key findings.

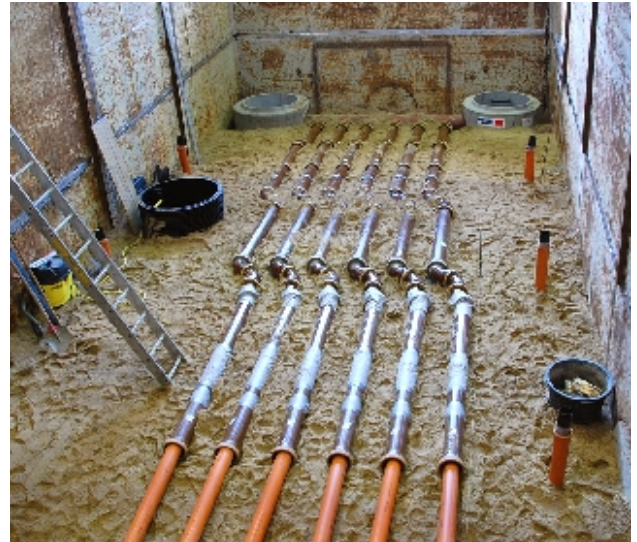
Lateral sewers including material changes, damage scenarios and bends being installed for evaluation of liners

An initial evaluation of lateral sewer lining systems against groundwater infiltration yielded an unexpected result – circumferential **cracking of the liners** at the location of host pipe joints. The cause was determined to be that the **products bonded too tightly** to the host pipe to be able to flex when pipe sections moved relative to each other due to floatation as groundwater levels rose. The industry made **modifications** based on these findings, and satisfactory results were obtained for products submitted in a subsequent evaluation.
