# Why have we made a bigger hole in the floor of our laboratory?

IKT's Large Test Facility – as originally designed for pipe jacking

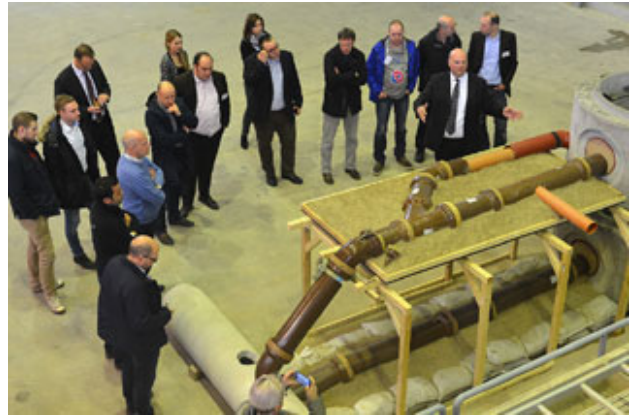
Project Steering Group considers 1:1 scale pipe layout to simulate house connections in the Large Scale Test Facility

The need for German sewer network owners to repair their own **small diameter sewers** and advise property owners on their private connections led to this examination of how effective **patch repairs** are in sealing damaged pipes against groundwater. Changes in pipe material, diameter, damage scenarios and bends were included in test rigs buried in the Large Test Facility and changing groundwater pressures were applied. Whilst **effective repair is possible**, special attention has to be paid to using the right product for some situations, like changes in pipe diameter.

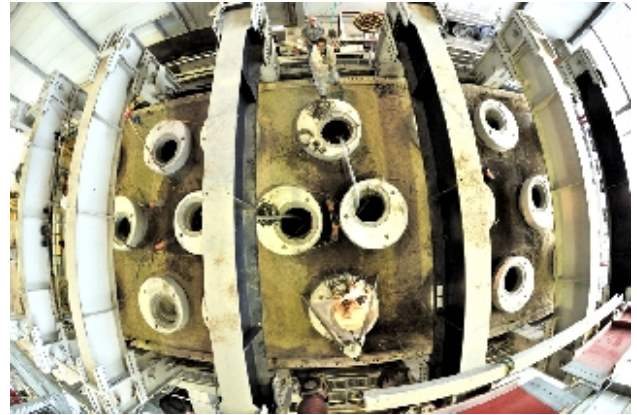
Many manholes buried in the Large Test Facility

**13 manholes with simulated damage** were installed into the Large Test Facility into which different products that are representative of available **rehabilitation technologies** were installed. The experiment also included one new plastic manhole to examine whether it would float out as groundwater rose.

It was proven that it is **possible to seal** against ground water, but results were variable across the range of technologies. There was one **complete failure** of a product against groundwater pressure and various damages/imperfections observed in others. The vital necessity for **good substrate preparation** for products that bond to the wall and advice to wait until groundwater has risen before undertaking acceptance inspections were key findings.

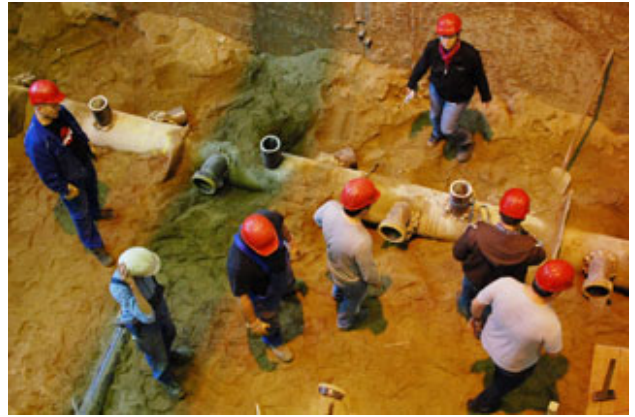
Project Steering Group members examine repaired lateral connects in the bottom of the Large Test Facility after excavation following exposure to rising groundwater pressure

The connections of lateral sewers to main sewer are a common cause of **groundwater infiltration** so this project used the Large Test Facility to investigate how repair technologies could seal them in different situations:

- repairs to lateral connections in a CIPP lined sewer
- repairs to lateral connection in un-lined sewers
- laterals joining at different positions and angles
- repairs in pipe half-filled with water

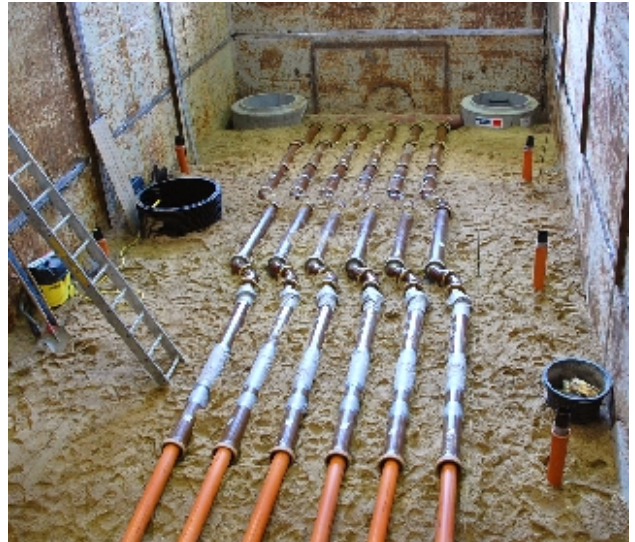
Lateral sewers including material changes, damage scenarios and bends being installed for evaluation of liners

An initial evaluation of lateral sewer lining systems against groundwater infiltration yielded an unexpected result – circumferential **cracking of the liners** at the location of host pipe joints. The cause was determined to be that the **products bonded too tightly** to the host pipe to be able to flex when pipe sections moved relative to each other due to floatation as groundwater levels rose. The industry made **modifications** based on these findings, and satisfactory results were obtained for products submitted in a subsequent evaluation.
