# Two-Meter CIPP Giant, Zero Downtime: UV-Cured GRP Relines Main Collector in Belgium

First in Belgium: a DN 2000 sewer collector that can't stop for a second is being rehabilitated with UV-cured GRP liners. The unique twist? They have to keep a whole city running with a bypass of 13,000 m<sup>3</sup>/h while crews worked just before the treatment plant. To show how that's engineered, international experts were invited on site. Amongst them: IKT's Ashwini Ausekar, who shares insights from her site visit.

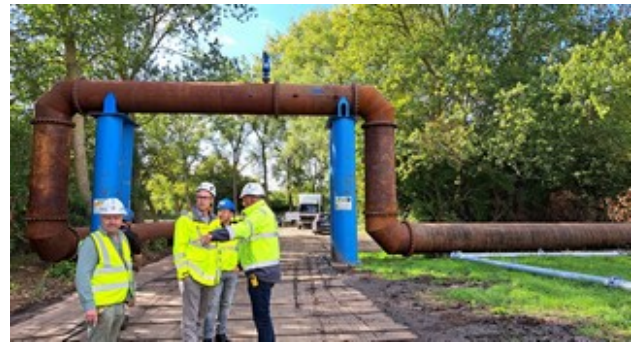
Bypass of 13,000 m<sup>3</sup>/h: Pumping stations and pressure sewer pipes to divert the flow from the rehabilitation stretch to ensure continues flow towards WWTP

To guarantee continued wastewater transport during the works, a temporary bypass pumping system was installed, capable of **diverting up to 13,000 m<sup>3</sup>/hour** to the treatment plant. This ensured uninterrupted operations while rehabilitation proceeded in 60-hour continuous shifts.

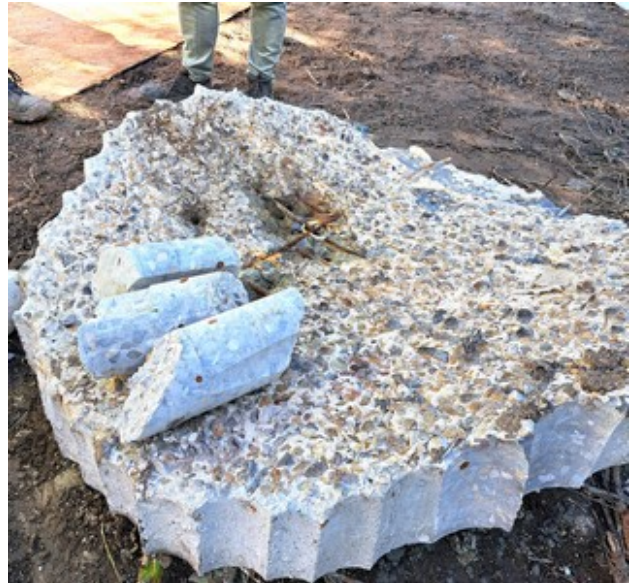
Extracted piece of host reinforced concrete pipe shows corrosion with coarse aggregates and dissolved reinforcement bars.

Inspection revealed that the reinforced concrete host pipes, originally 19 cm thick, had in some places been reduced to as little as 2 cm due to severe corrosion **caused by hydrogen sulfide ( $\text{H}_2\text{S}$ )**. In certain sections, reinforcement steel had already dissolved. Without intervention, the risk of sewer collapse and subsequent sinkholes would have been high, with major social, ecological, and economic consequences.

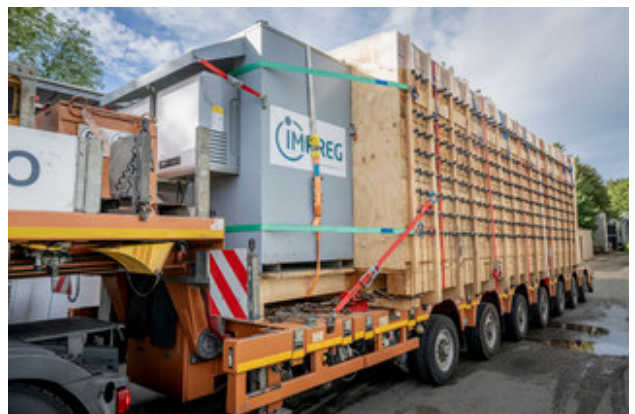
100 tonnes on the way: the DN

2000 large CIPP liner from Impreg

This remarkable rehabilitation covers a total length of 156 meters, installed with a pull-in method and cured using 36 kW UV lamps progressing at approximately 45 cm per minute. The GRP liners, supplied by Impreg, were transported to site with a total weight of 100 tons.
