# After six years: IKT researchers dig up their test stand for tree roots

After six years of growth: IKT researchers dig up their tree root test stand in Almere (Netherlands)

How to keep roots away from sewage pipes? IKT investigates protection systems in a long-term project. Researchers want to find out which protective measures are suitable. They have now dug up their worldwide unique in-situ test rig. The initial results are surprising.

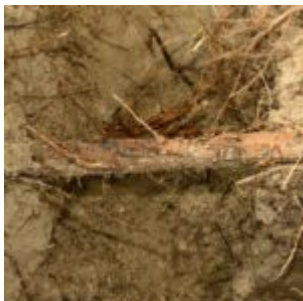
Horizontal root ingrowth in the pipe trench
