After six years: IKT researchers dig up their test stand for tree roots

After six years of growth: IKT researchers dig up their tree root test stand in Almere (Netherlands)

How to keep roots away from sewage pipes? IKT investigates protection systems in a long-term project. Researchers want to find out which protective measures are suitable. They have now dug up their worldwide unique in-situ test rig. The initial results are surprising.

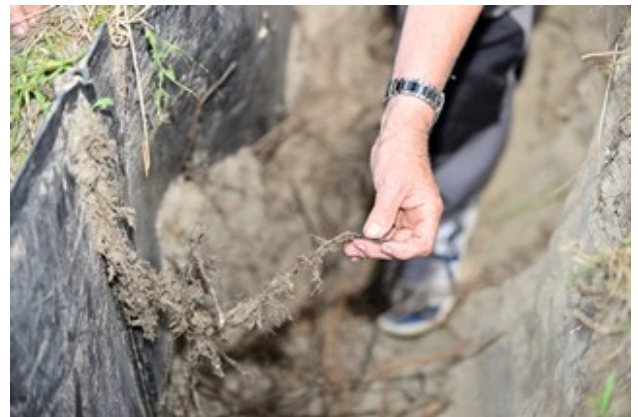
Despite protective mats: Roots continued to grow merrily

Some roots penetrated deeper into the earth along the vertical protective plates, only to grow upwards again behind the obstacle. Others bypassed the protection systems sideways. All of them grew towards the bedding zone of the pipes, probably because the soil is less compacted there and they can advance more easily than in the natural soil space.

Of the 15 pipe connections, 13 withstood the roots, two did not. The connections between the vertical protective plates were also not impenetrable in all cases. The roots snaked through here too.

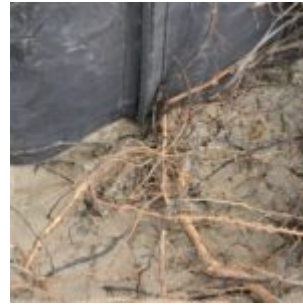
Protective mat to stop roots

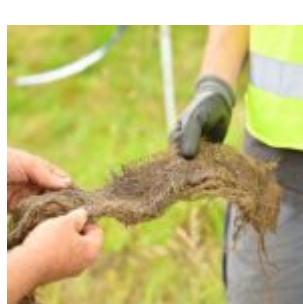
Root mats excavated from the IKT test stand

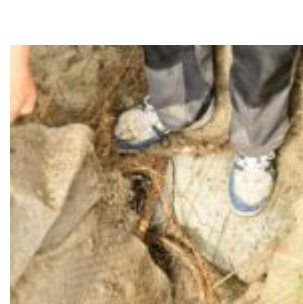
Protective mat, roots and sewage pipe

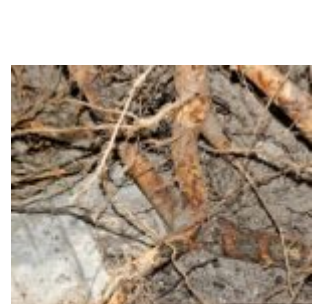
Almost like an ancient Roman trident: tree roots grow towards the sewage pipe

Visually alone, there was something unexpected: even thick roots branched out like an ancient Roman trident when they encountered resistance. They followed the relatively loose soil space around the sewage pipes. They looked for their way and found it. They bypassed the built-in obstacles – successfully at first glance.
