## Down Under: What are the performance limits of CIPP liners?

## What Goes Back Into the Sewer Trench? — Flowable Backfill Materials Put to the Test

# After six years: IKT researchers dig up their test stand for tree roots

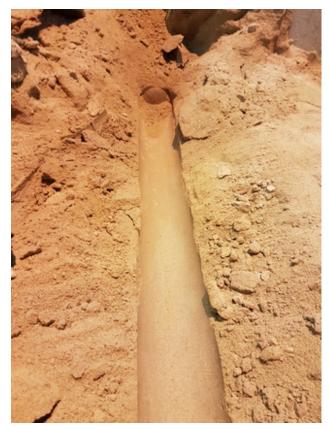
Pipe enclosure without defects (DN 100)

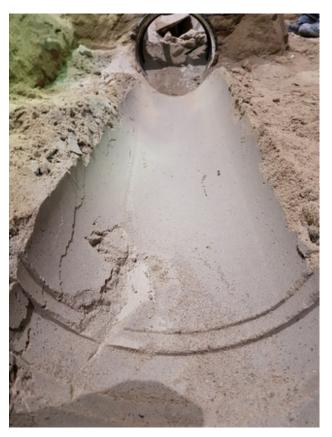
Pipe enclosure with minor defects (DN 300)
