# Slight disappointment on wall thickness

CIPP-liner samples from six countries tested. Test results still at high level. Only wall thicknesses are more frequently below target. Most non-German companies also score well.

The IKT - Institute for Underground Infrastructure hereby presents its twelfth annual LinerReport. The report is based on just on 2,150 CIPP-liner samples taken for quality-control purposes on project sites and tested by the IKT CIPP Liner Test Centre in 2015.

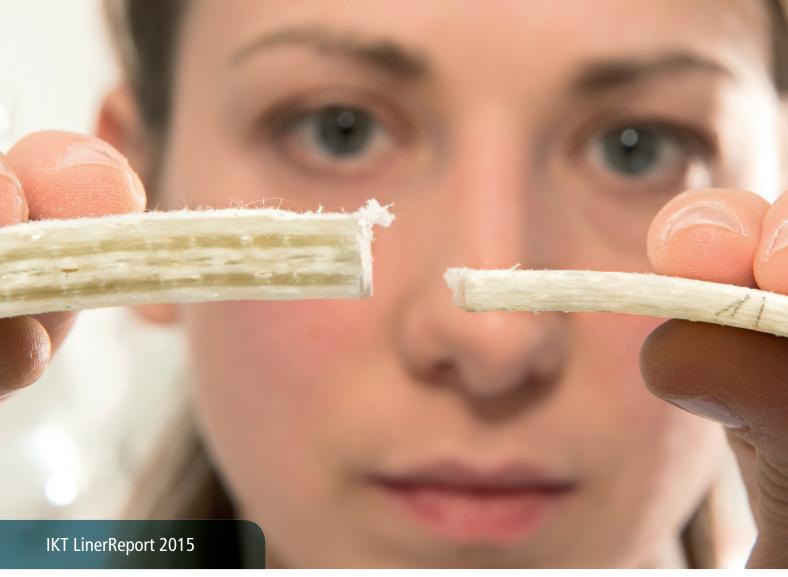
Precision measurement necessary: wall thicknesses differ

- Minimum values are specified in the structural-analysis calculation
- Wall thickness and modulus of elasticity jointly determine the stiffness of the
- Excessively low wall thickness can endanger stability
- Test method: Average combined thickness is measured in acc. with DIN EN ISO 11296, Part 4\*\* using a precision slide gauge
- > Results: see Table 4

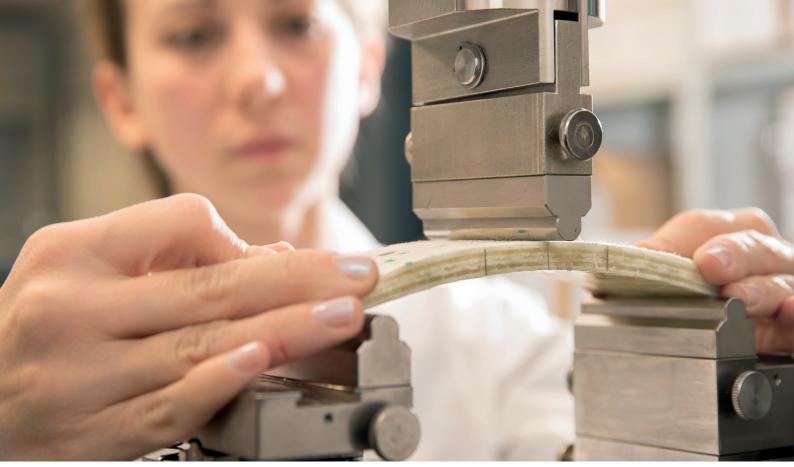
Three-point bending test on CIPP liners

- CIPP-liners must withstand loads such as those caused by groundwater, road traffic and soil pressure
- The modulus of elasticity is an indicator of load-bearing capability
- Stability may be endangered if modulus of elasticity is too low
- Test method: Three-point bending test in acc. with DIN EN ISO 178 and DIN EN ISO 11296, Part 4/DIN EN 13566, Part 4\*
- > Results: see Table 2

- This denotes the point at which the liner fails as a result of excessively high stress
- The liner may rupture before the permissible deformation is reached if flexural strength is too low
- Test method: Increase of load up to failure in the three-point bending test in acc. with DIN EN ISO 178 and DIN EN ISO 11296, Part 4/DIN EN 13 566, Part 4\* (short-term flexural strength)
- > Results: see Table 3
