Watertight or not? Water tightness testing in the IKT laboratory

15 years of the IKT LinerReport

# Has the trend for improving sewer lining quality ended?

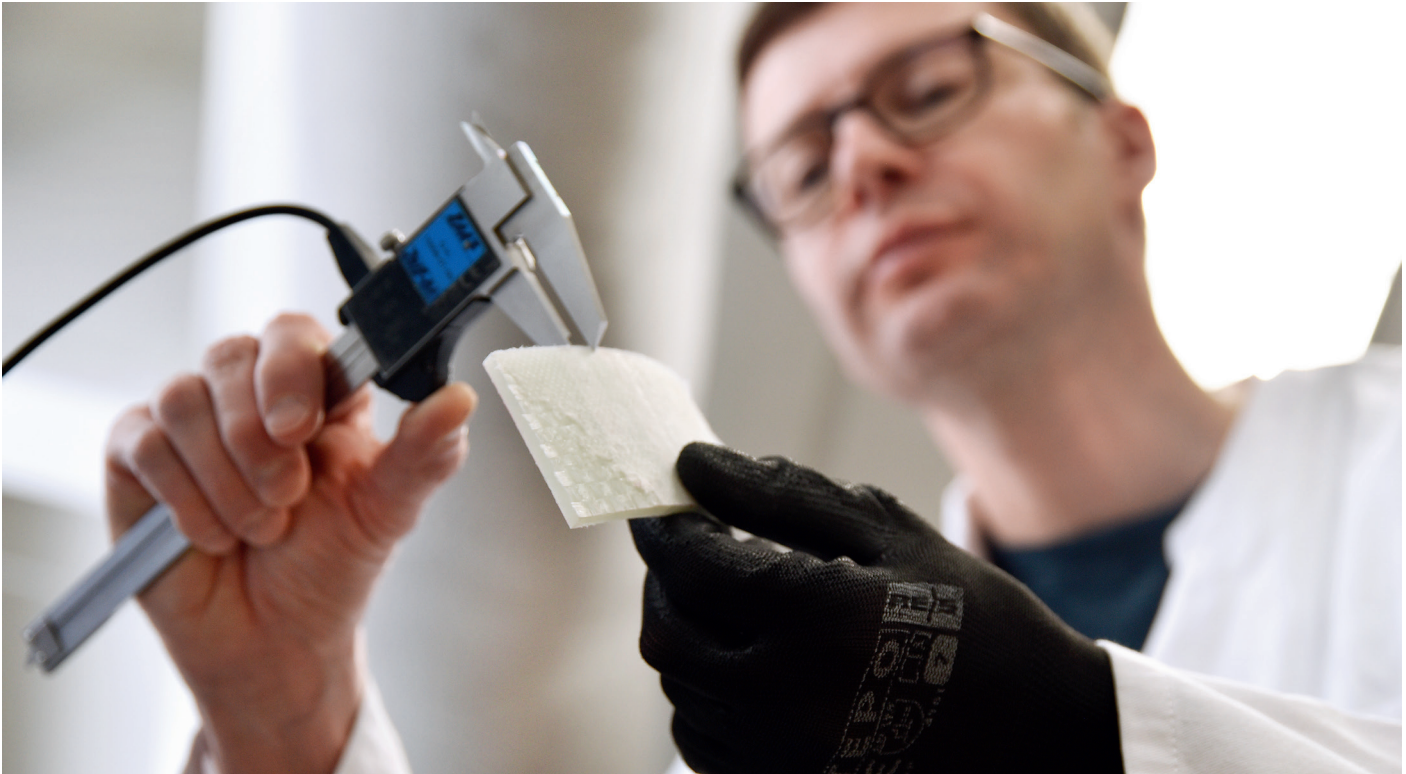
Wall thickness measurement: requires particularly high precision

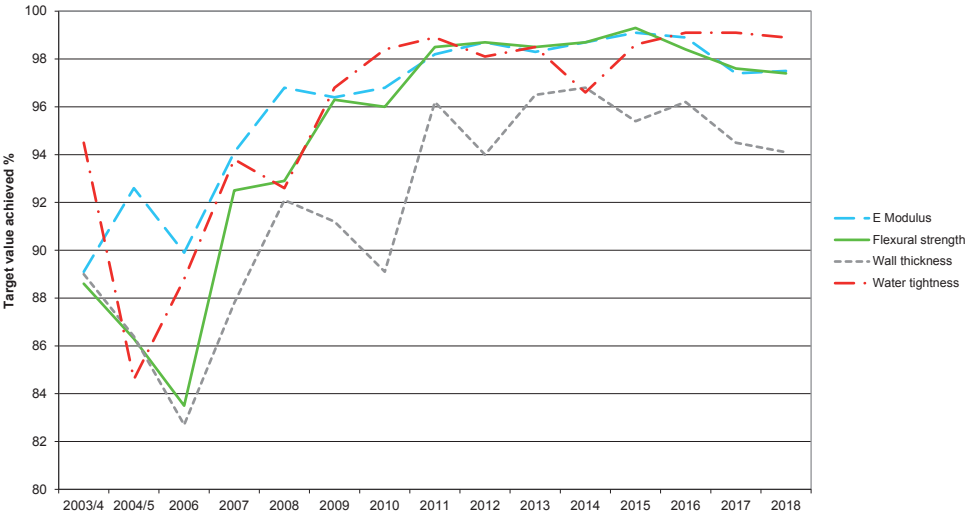
**Figure 2: Annual test results from 2003 to 2018 showing the percentage of samples achieving their target value.**

The overall trends observed in the test results over the last 15 years have been positive. Until the mid-2000s, 15 to 17 percent of all pipe liner samples did not pass the tests. Since then, the failure rate has reduced to 1 to 6 percent, which is a pleasing overall picture. However, this is slightly clouded by the fact that after very good success rates, approaching 100 percent for some test criteria, the proportion of failed tests has noticeably increased in the second half of the 2010s, with the exception of water tightness (Figure 2).

The wall thickness test criterion shows the weakest performance among the four tests in all 15 years of the IKT LinerReport, consistently recording the lowest pass rates. Although the results of the wall thickness tests today are better than 15 years ago, with a success rate of 94% in 2018, it remains the criterion with the worst results. It should be borne in mind that this failure rate of 6% means that approximately every 15th liner does not achieve the wall thickness expected by the customer (Figure 2).

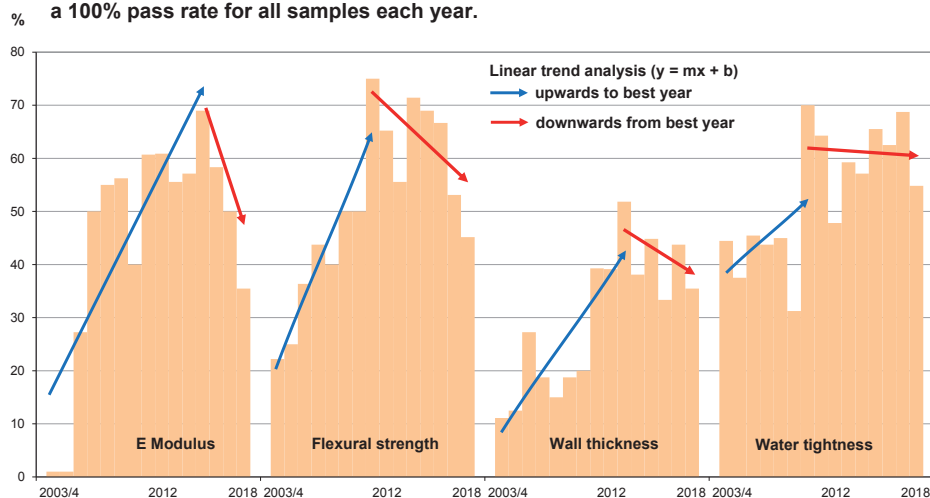
**Figure 3: Proportion of CIPP lining companies that achieved a 100% pass rate for all samples each year.**

nies succeeded in passing the Modulus of Elasticity test criterion for all the samples submitted. From then on, the trend reversed and the proportion of companies that passed with all samples dropped to 35% by 2018 (Figure 3). Similar trends can also be observed for the other three test criteria. In 2011, 75% of the lining companies passed the bending strength test, seven years later it is only 45%. For wall thickness, 2013

was the best year with 53% of companies passing these tests with all their samples, compared to only 35% in 2018. Only for water tightness is the decline somewhat smaller, from 70% of companies in 2010 to 55% in 2018 (Figure 3).

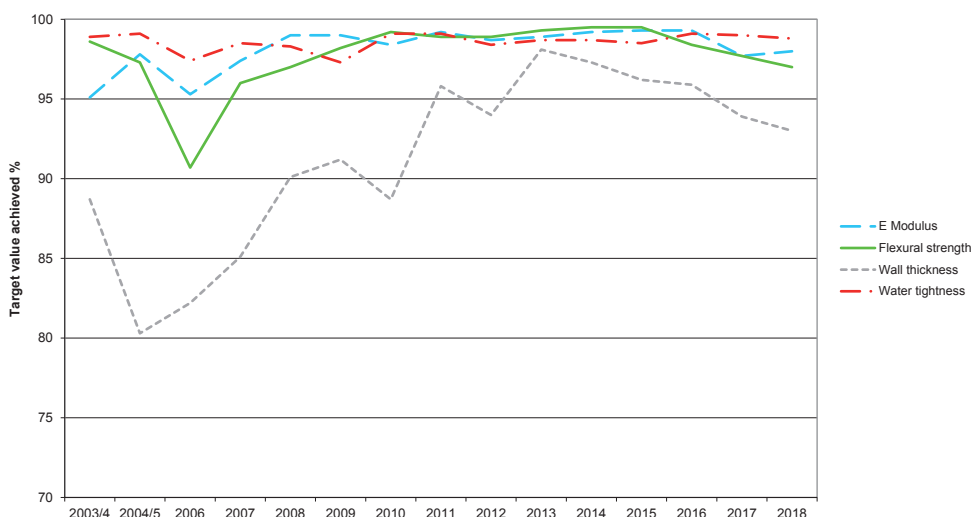
**Figure 4: Test results for GRP liners – percentage of samples achieving their target values each year.**

Both GRP and NF liners show improved performance over the last 15 years. For NF liners, this improvement is more pronounced, albeit from a lower initial level than for GRP liners. The GRP pass rates are in a narrow range of 95 to 99 percent over almost all years. The only exception is the wall thickness, which in the case of GRP liners is significantly weaker than the other three test criteria (Figures 4 and 5). NF liners, on the other hand, show a significantly

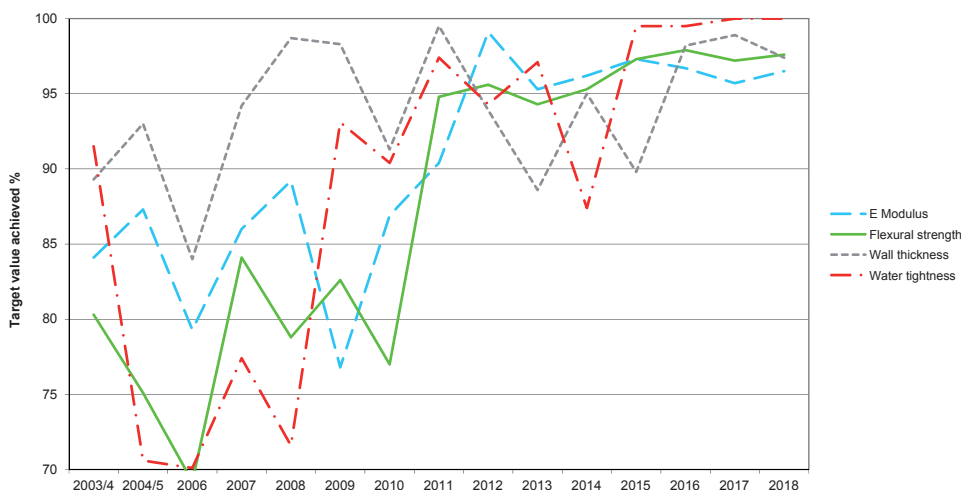
**Figure 5: Test results for needle felt liners – percentage of samples achieving their target values each year.**

higher variance in their test results over time. Only in the last three years have the results of the four criteria settled at a high level between 95 and 100 percent. It is noteworthy that no NF liner has failed the water tightness test for the past two years, as for many years NF liners performed poorly for this test (Figure 5).

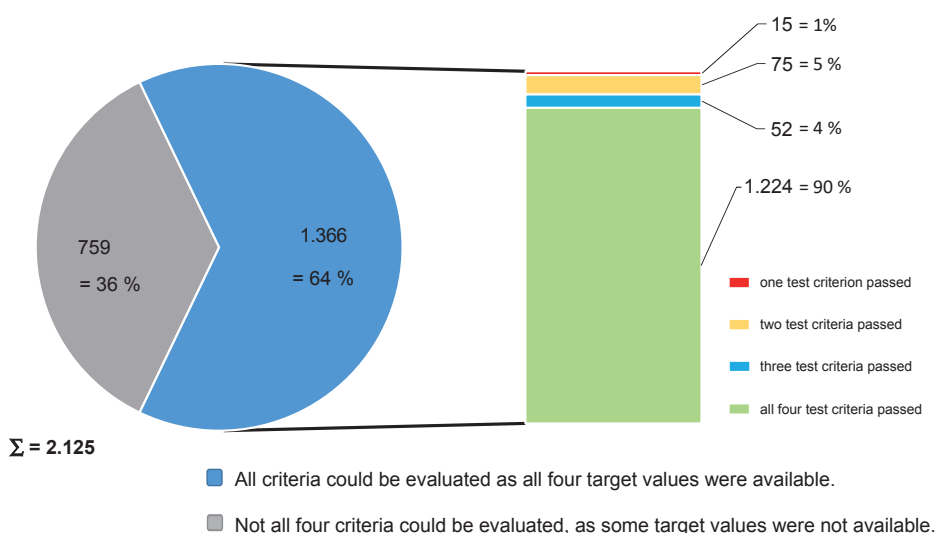
Figure 6: Summary of the number of samples that passed test criteria in 2018.

For about two thirds of the liner samples tested by the IKT testing laboratories in 2018, required target values for all four criteria were available. Only if all four target values are known, can a complete evaluation of the sample against all criteria be made. At least one target value was missing for one third of the samples. Of the total of 1,366 samples with all four nominal values, 90% met the requirement for all four test criteria. So, one tenth failed at least one test criterion (Figure 6).

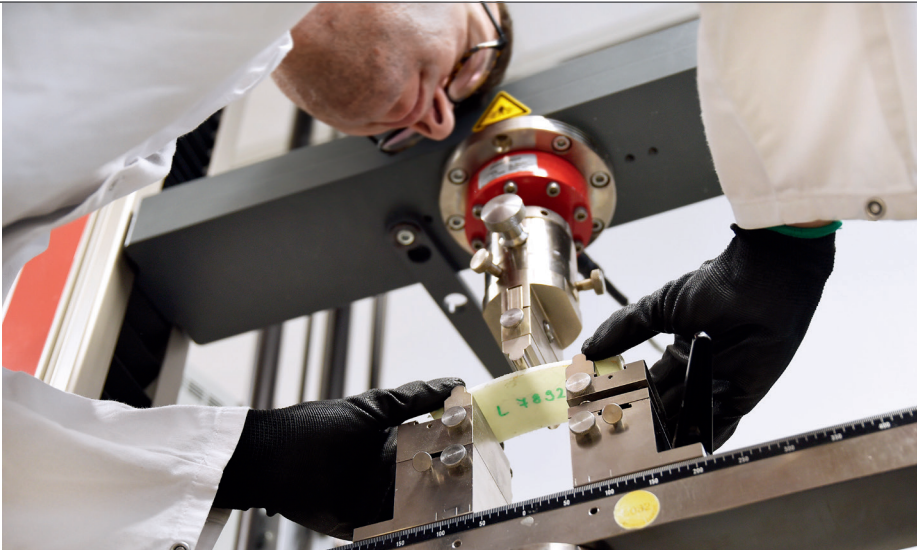
Three-point bending test: mechanical testing of modulus of elasticity and bending strength
