2019 IKT LinerReport

Seven Percent of Sewer Liner Samples do not Pass all Tests

by Roland W. Waniek, Dieter Homann and Barbara Grunewald

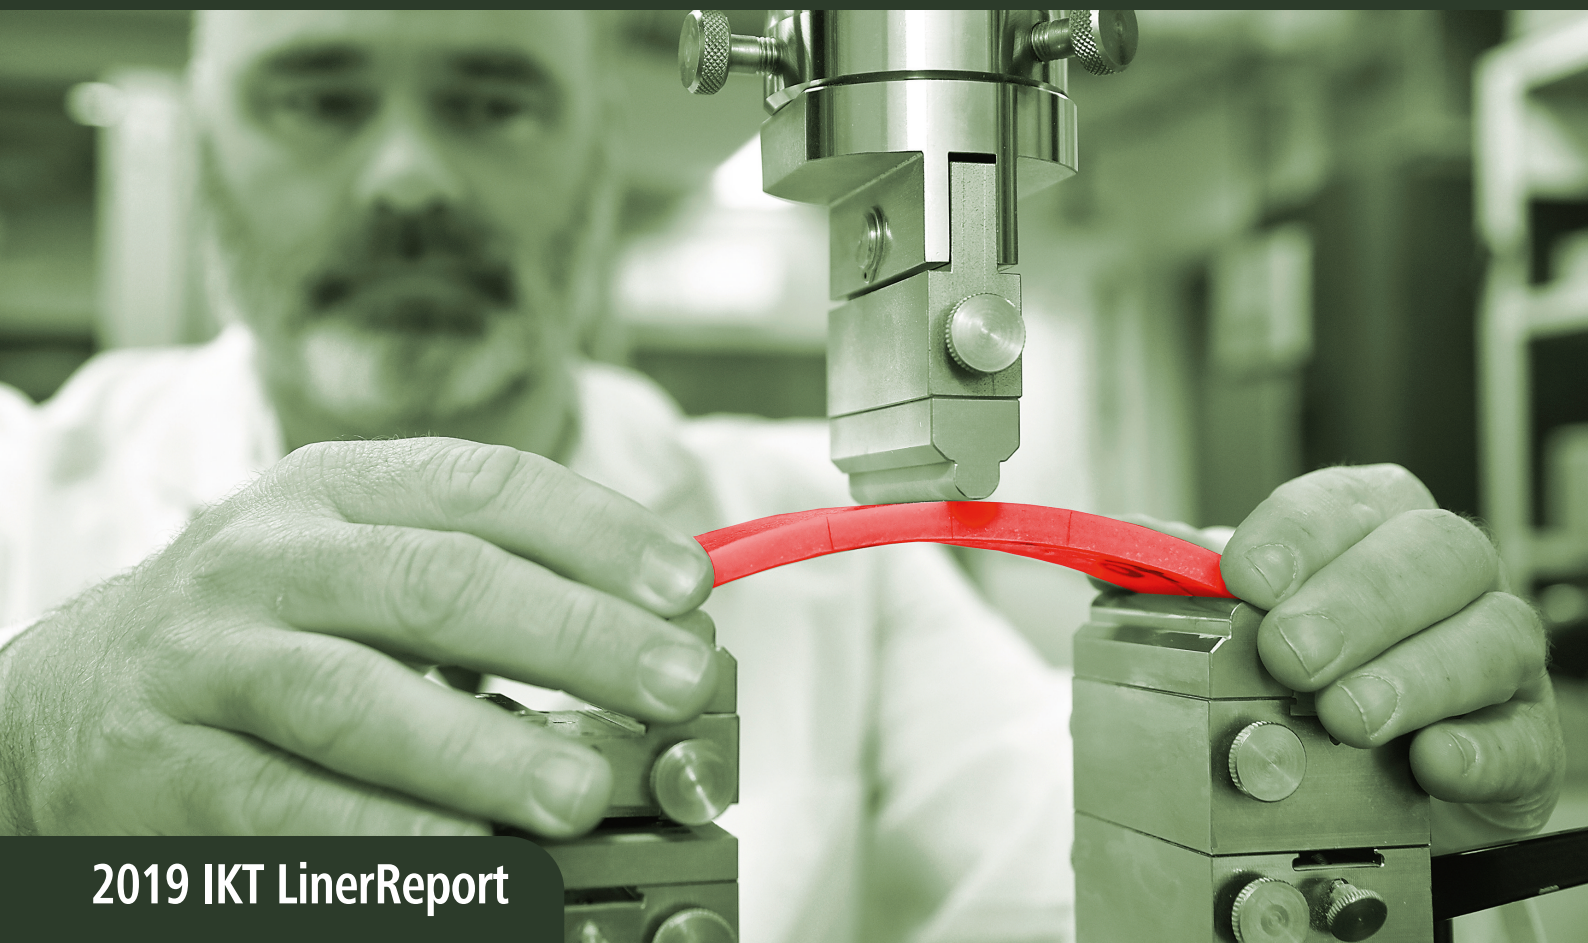
Figure 1: Three-point bending test: mechanical testing of modulus of elasticity and flexural strength

- CIPP liners must be capable of bearing loads such as groundwater, road traffic, and soil pressure
- The modulus of elasticity is an indicator of load-bearing capability
- Stability may be endangered if the modulus of elasticity is too low
- Test method: three-point bending test in accordance with DIN EN ISO 178 and DIN EN ISO 11296-4

- This denotes the point at which the liner fails due to excessive high stress
- The liner may rupture before the permissible deformation is reached if flexural strength is too low
- Test method: Increase of load up to failure in the three-point bending in accordance with DIN EN ISO 178 and DIN EN ISO 11296-4

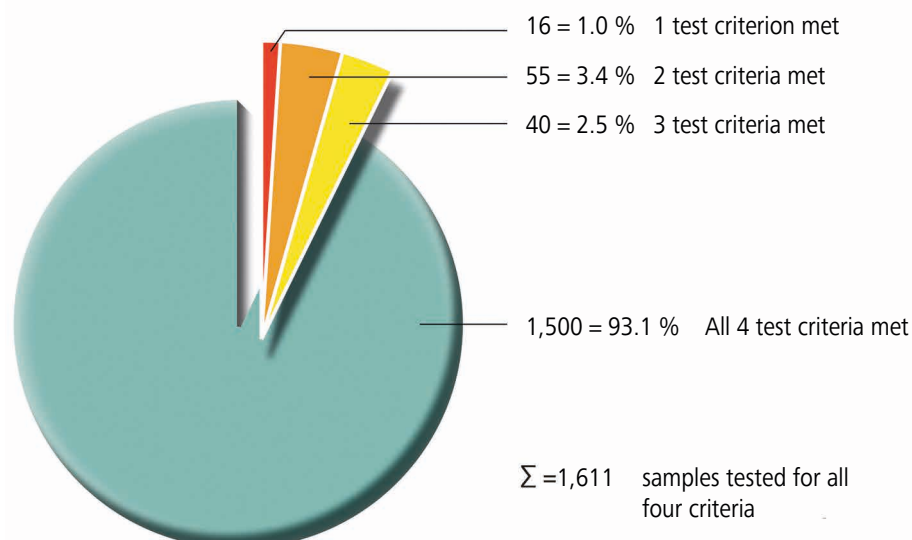
Diagram 1: Percentage of individual liner samples that passed 1, 2, 3 or all 4 tests

Diagram 1 shows that of the 1,611 samples (two thirds of all samples) for which all four nominal values are available:

- 93.1% pass all four test criteria,
- 2.5% pass only three test criteria,
- 3.4% pass only two test criteria, and
- 1.0% pass only one test criterion.

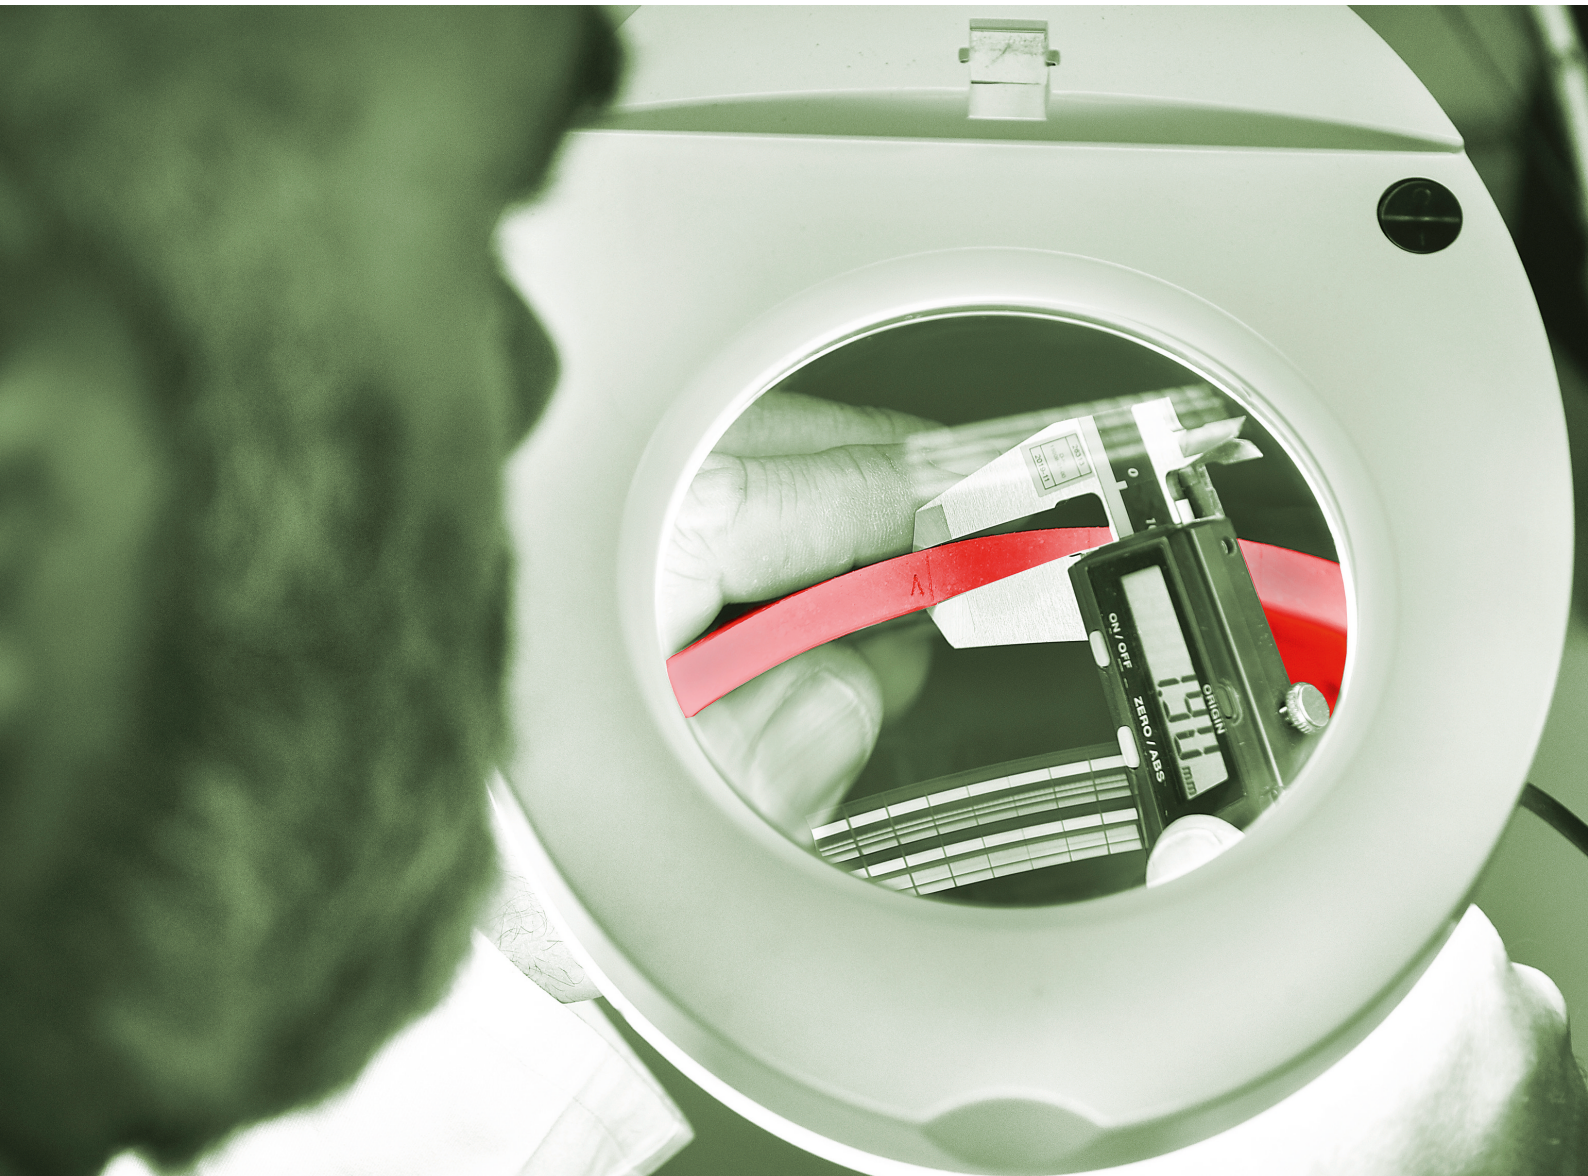
Figure 2: Wall thickness measurement: requires particularly high precision

- Excessively low wall thickness can endanger stability
- Minimum values are specified in structural analysis calculation
- Wall thickness and modulus of elasticity jointly determine the stiffness of the liner
- Test method: with precision a caliper average composite thickness is measured in accordance with DIN EN ISO 11296-4
