# IKT-Comparative Product Test

## Rehabilitation methods for wastewater pressure pipes - Class A liners -

Gelsenkirchen, November 2022

## **IKT-Comparative Product Test Report:**

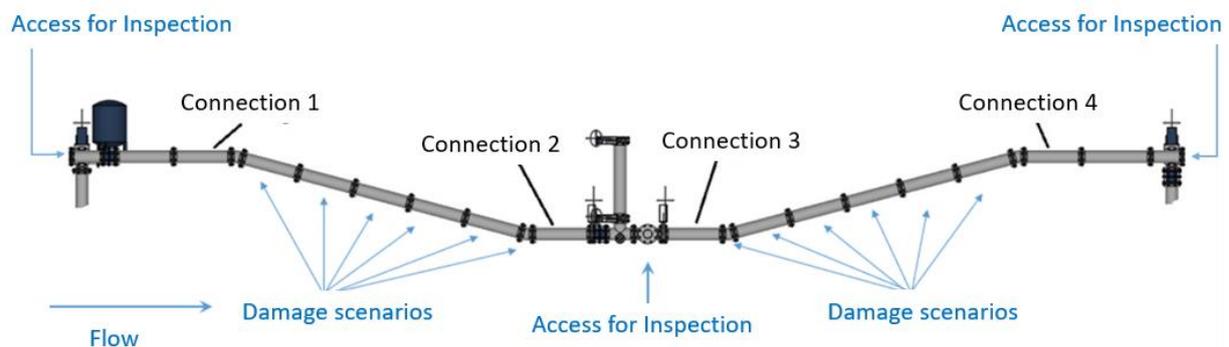
Figure 11. Above-ground test pipeline layout with the location of damage scenarios, access points and connections(end seals). Following installation of a liner the rig contained two sections of liner, each with an end seal at either end: Section 1 between Connections 1 and 2, and Section 2 between Connections 3 and 4. The access module between Connections 2 and 3 was not lined.

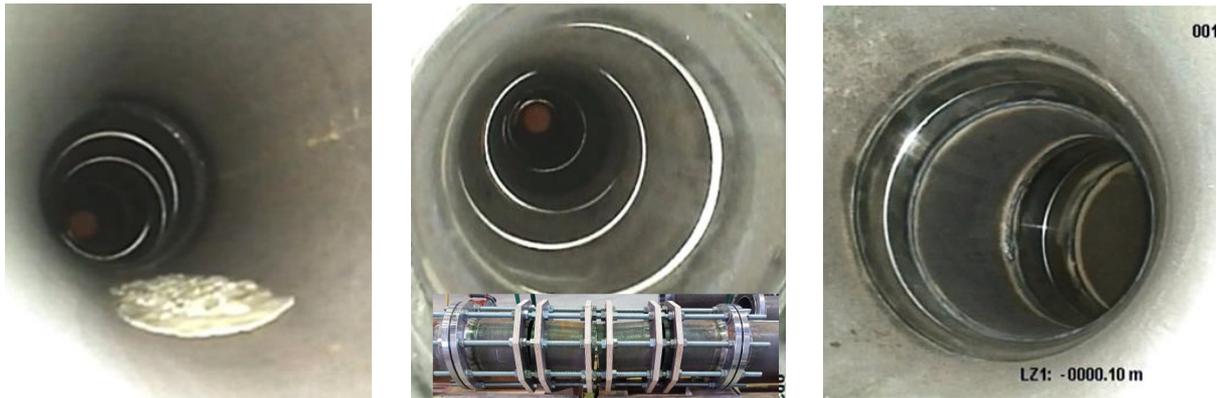
All manufacturers renovated the damage scenario "transverse cracks with angular deflection" and "shard load". "Wavin", "Esders", Amex" and "Karl Weiss" renovated the damage scenario "incrustation". The "maximum rehabilitable bend" observed was 30°. "Norditube" refrained from installing into an additional bend. Therefore, 15° was recorded as the "maximum rehabilitable bend" for their product, as 15° bends were renovated in the course of the loading and testing programme (system tests). The damage scenario "double overlapping hole" was renovated by "Esders", "NordiTube", "Amex" and "Karl Weiss". "Wavin" and "egeplast" did not carry out the renovation of this damage scenario (Table 36). In the case of the "Compact Pipe", "Esders HPS Liner" and "SaniPipe" systems, anomalies without significant restrictions on watertightness, stability and operational performance were evident after the "shard load" testing.

Figure 32. Damage scenarios "incrustation" (left), "transverse crack with angulation" (centre) and "max. rehabilitable bend" (right).

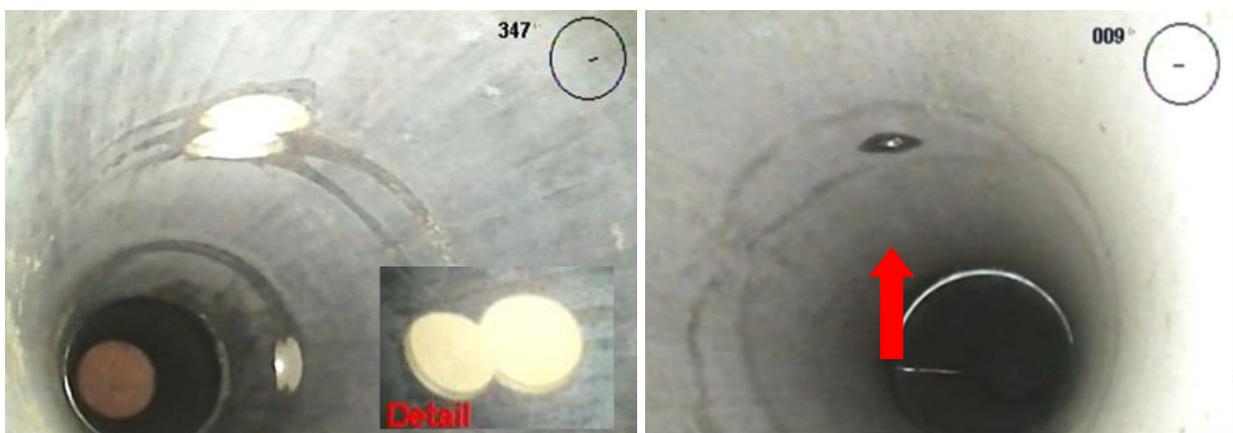
For the damage scenario "double overlapping hole" and "shard load", the planned loading and testing programme was carried out during the testing programme. In addition, the application of the "shard load" was continued after the completion of the large-scale tests up to a total load duration of 188 days. The other three damage scenarios served only as supplementary renovation tasks; these renovated sections of pipe were removed after installation before the test rig was put into operation.

Figure 33. Damage scenario "double overlapping hole" (left) and shard load, simulated by insertion of a weighted punch through a hole in the crown ( $F = 300\text{ N}$ , shard punch =  $\varnothing$  shank 6 mm/  $\varnothing$  tip 2 mm) (right).
