# Withstanding the pressure: liners for pressure sewers put to the test

Pressure sewer pipes like gravity sewers that are getting on in years need to be renovated. But, which methods are suitable? What are their strengths and weaknesses? The recent IKT comparative product test on pressure sewer liners provides answers.

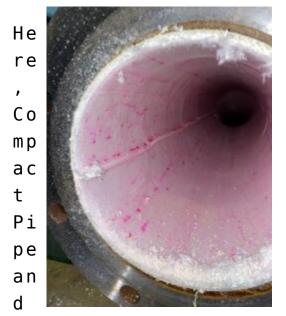
$_{\mbox{eg}}\mbox{Clearly recognisable longitudinal fold in an installed liner eL}$
