IKT Compare: Can Short Liners Repair House Connections?

How do short liners perform? IKT figured it out in its latest IKT Compare project.

Short liners are often the first choice for repairing local damage in house connections. But, can they deal with seriously damaged pipes? The results of the new IKT-Compare project "Short Liner for House Connections" are now available.

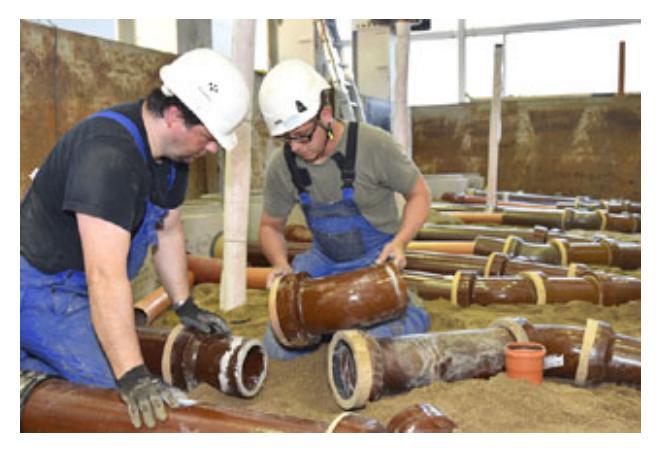
Deliberate defects: IKT has installed eight test sections with a total of 64 cases of damages in its large test pit.

For this project IKT built eight identical **1:1 scale rigs**, in its large-scale test pit (15m by 6m by 6m), into which suppliers installed their short liners. Each rig comprised a

length of sewer to which were attached one house connection pipe on the same level as the sewer pipe and two house connection pipes from a higher level. The house connection pipes were prepared with defined areas of damage, including milled patterns of cracks, the removal of some or all of the joint seals and broken sections. A total of 64 damage patterns were produced – eight in each of the eight test rig setups.

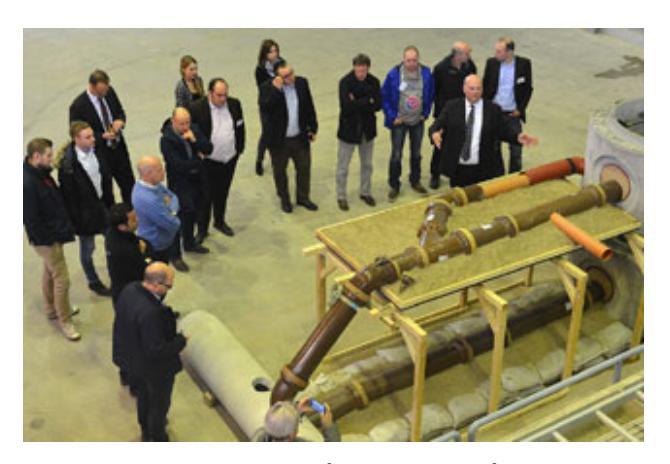
Two up, one down: the test set-up.

These patterns of damage were arranged as follows:

- Test Setup I (the lower house connection pipe, to which a 2m head of external groundwater was subsequently applied): cracks, a broken joint, a radially displaced joint and a joint displaced at an angle
- Test Setup II (the two higher house connection pipes, to which a 1m head of groundwater pressure was subsequently applied): a defective change of pipe material, defective change of pipe diameter and material from cast iron DN 150 to PVC DN 125, a defective change of pipe diameter and material from clay pipe DN 150 to PVC DN 125, and a break in the joint of a 45 degree bend

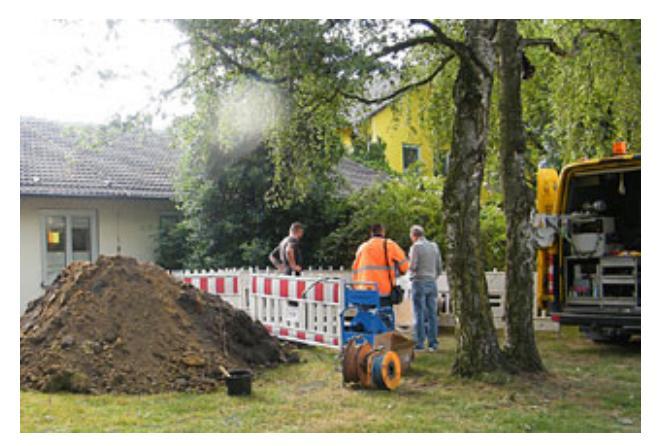
In-situ tests: lab tests were validated through in-situ observation of the same systems being installed at actual construction sites.

In addition to physical tests, the QA/QC procedures were examined. The laboratory results were validated through insitu observation of the same systems being installed at actual construction sites. The final scores in this IKT Compare test are based on these three evaluations. The range of grades applied is from VERY GOOD (score of 1.0) to INSUFFICIENT (score of 6.0).

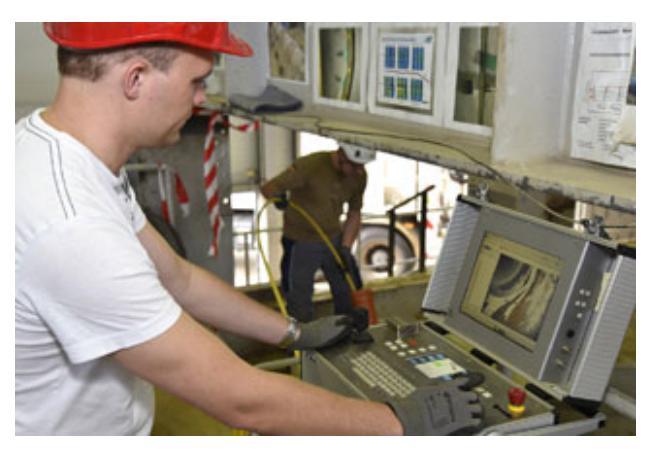
Ongoing observation. IKT testers regularly check the installed short liners for leaks.

Frequent visual inspections and leak tests were undertaken as the programme progressed. Finally, when the test rigs were exhumed from the test-pit, the **cross-section reduction** was measured and the **adhesive tensile strength** and **ring stiffness** of the installed liners were assessed.

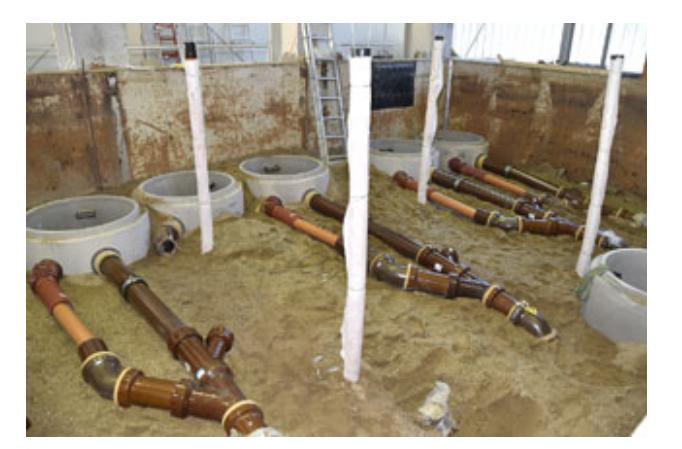
Repair objective: to seal damaged house connections.

In this IKT Compare project, the system suppliers demonstrated that **serious damage** to house connections can be **reliably sealed** using short liners, including breaks, cracks, misalignments and deflections. In particular, the **Twinbond** and **Trelleborg** systems proved to be the **most reliable** under permanent groundwater load, jetting, simulated backflow events and changing groundwater levels. For this they were deservedly awarded the **score of 1.0** for water tightness.

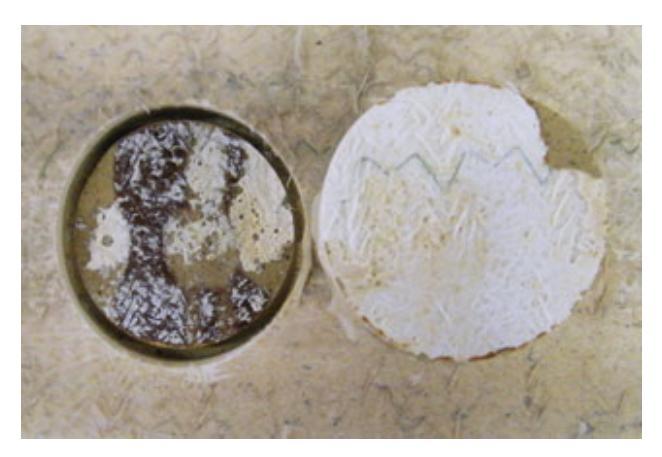
Adhesion test

The structural stability testing of the short liners showed that they basically have **reliable adhesive and load-bearing performance**. For products with full-surface bonding of the liner to the host pipe, hardly any abnormalities were observed, i.e. no crack formation, no excessive deformation, no stability failure nor large-surface loosening of the adhesive bond. Five systems showed **partial loosening** of the adhesive bond at points of changing diameter or pipe material, albeit without any consequences.

The Cosmic system is not intended to bond over the fullsurface, only at the start and end of the liner. However, the supplier was able to submit a **static proof** which confirmed the structural stability of the short liner observed in the test.

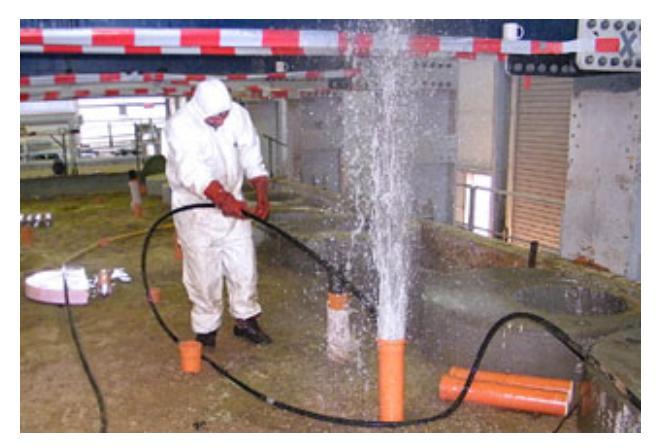
High-pressure jetting did not affect the short liners.

The test scenarios **simulating sewer operation**, such as highpressure jetting, water backing-up in the pipe, and changing groundwater levels, had **no significant effects** on system performances.

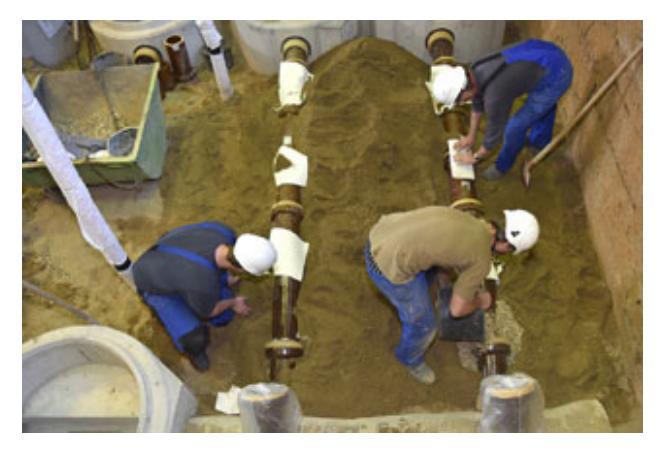
Defined damages: preparing the test rigs
