# IKT to take part in €4M Horizon 2020 project to build collaborative Urban Drainage research labs communities

## Rainwater treatment: IKT can now also test systems according to a US regulation

# IKT LinerReport 2020: CIPP liners meeting target values at six-year low

## **Why have we made a bigger hole in the floor of our laboratory?**

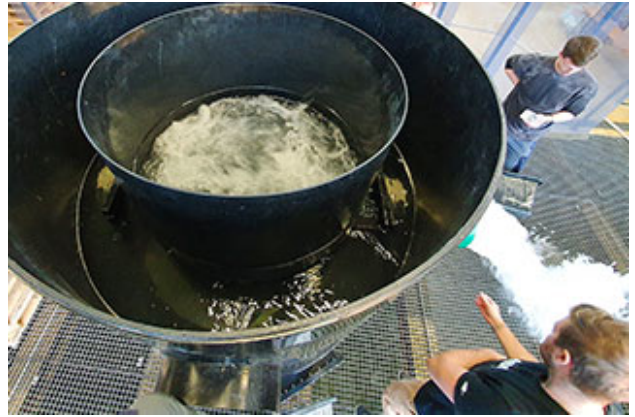
For the first time, IKT has tested a decentralised rainwater treatment facility according to the NJDEP protocol.

For the first time, **IKT's Test Centre for Rainwater Treatment** has tested a decentralised stormwater treatment system according to the US **NJDEP standard**. The treatment process of the Hydroshark system from 3P Technik Filtersysteme was evaluated in laboratory tests and its performance determined. Prior to this, the product had already been tested by the IKT test centre in accordance with the **Trennerlass NRW** (the surface water separation decree of the State of North Rhine-Westphalia, Germany).

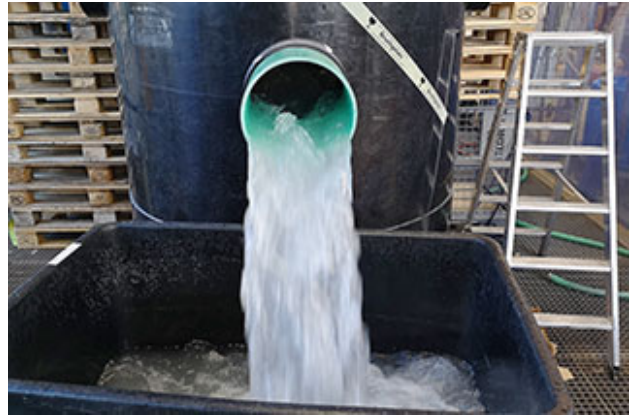
What comes out the other side?  
The NJDEP test procedure determines the retention capacity of the system.

The system was tested for **sediment removal efficiency** in accordance with Section 5 of the NJDEP protocol, using a test sediment mixed according to the requirements of the protocol. The following **parameters and performance data** were obtained for the Hydroshark during the seven test runs that are required:

- Maximum Treatment Flow Rate (MTFR): 1.60 cfs (45 L/s)
- Total Suspended Solids (TSS) removal efficiency: > 50 % at MTFR
- Effective treatment area (ETA): 18.94 ft<sup>2</sup> (equivalent to 1.76 m<sup>2</sup>)
- Volume: 924 gal (equivalent to 3,498 litres)
- Effective Sedimentation Area (ESA): 8.45 ft<sup>2</sup> (equivalent to 0.79 m<sup>2</sup>)
- Volume of sludge chamber: 233 gal (equivalent to 882 litres)

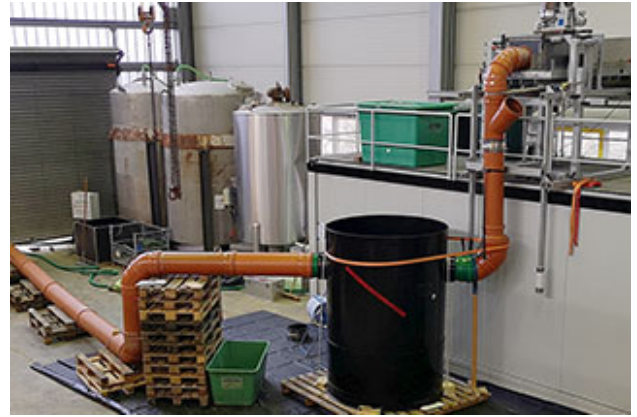
The Hydroshark system has already been tested at the IKT in accordance with the Trennerlass NRW.

A few months before the NJDEP test, the IKT Test Centre for Rainwater Treatment determined the **hydraulic capacity** and the **material retention capacity** of the Hydroshark DN1500 stormwater treatment plant in accordance with the Trennerlass NRW:

- Hydraulic capacity: > 50 l/s
- Retention of fine-grained, filterable mineral substances: 72.55 % retention
- Retention of coarse-grained, filterable mineral substances: > 99.00 % retention
- Retention of floating polyethylene: 62.24 % retention
- Retention of suspended solids from polystyrene: 75.41 % retention
- Retention of mineral oil hydrocarbons: 66.59 % retention

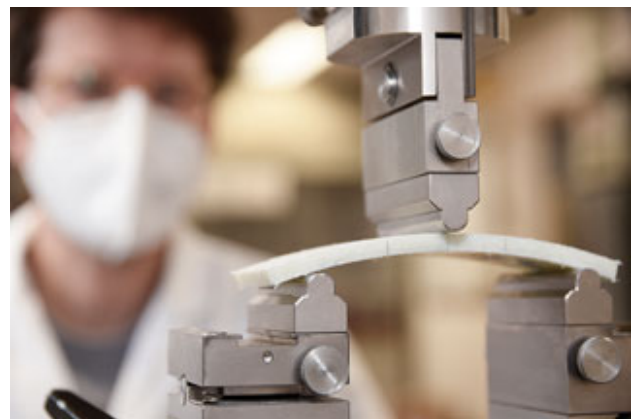
The results for all four test criteria dropped in comparison to previous years.

For the 17th time, IKT presents its **annual LinerReport**. This LinerReport for 2020 considers the short-term test results from a total of 2,613 **cured in place pipe (CIPP) liner samples**. The overall test results for 2020 are the **lowest in the past six years**. One CIPP liner sample in eight did not achieve its expected target value for at least one test criterion. However, the requirement is clear and unambiguous: **all four test criteria must be met** simultaneously by a sample. In 2020, this was achieved in only 87.5% of samples.

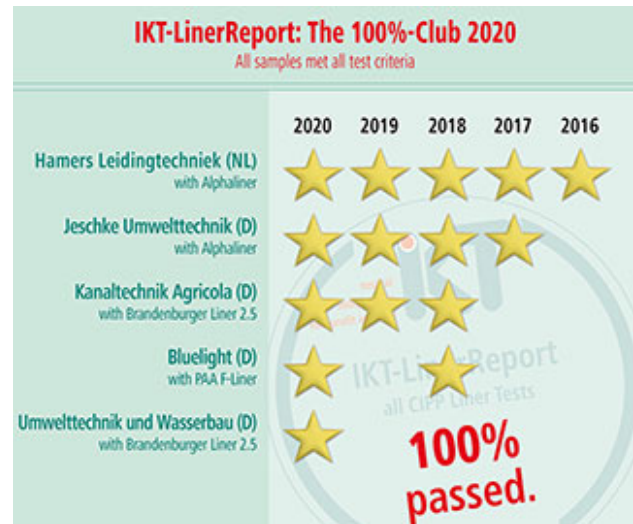
Table 3: The 100 % club of 2020 (click to enlarge)

A **high-quality liner** must fulfil all four test criteria simultaneously. In most cases, the target values against which test results were compared derive from declared values in a product approval and in a few cases they were provided by the site-specific static calculations from the customer's specification. In 2020, five out of 27 rehabilitation companies achieved the target values in all four test criteria for all their samples (the previous year it was three out of 23), so they **meet the quality requirements in full** at each of their installation sites.

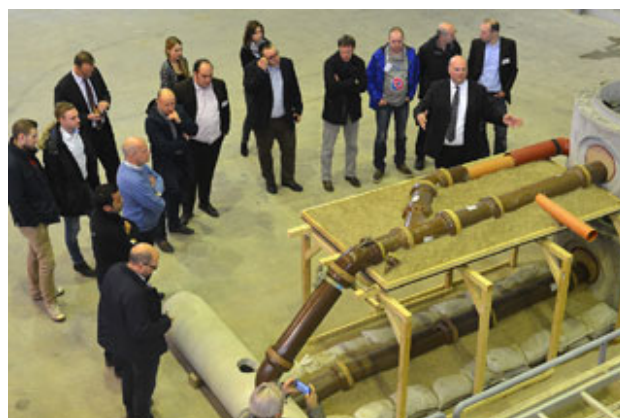
Project Steering Group  
considers 1:1 scale pipe  
layout to simulate house  
connections in the Large Scale  
Test Facility

The need for German sewer network owners to repair their own **small diameter sewers** and advise property owners on their private connections led to this examination of how effective **patch repairs** are in sealing damaged pipes against groundwater. Changes in pipe material, diameter, damage scenarios and bends were included in test rigs buried in the Large Test Facility and changing groundwater pressures were applied. Whilst **effective repair is possible**, special attention has to be paid to using the right product for some situations, like changes in pipe diameter.

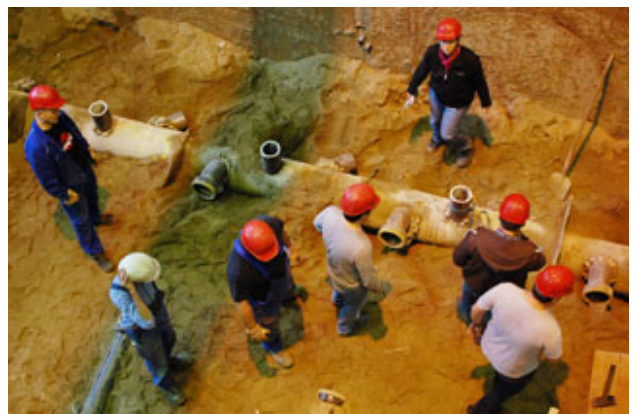
Project Steering Group members

examine repaired lateral connects in the bottom of the Large Test Facility after excavation following exposure to rising groundwater pressure

The connections of lateral sewers to main sewer are a common cause of **groundwater infiltration** so this project used the Large Test Facility to investigate how repair technologies could seal them in different situations:

- repairs to lateral connections in a CIPP lined sewer
- repairs to lateral connection in un-lined sewers
- laterals joining at different positions and angles
- repairs in pipe half-filled with water

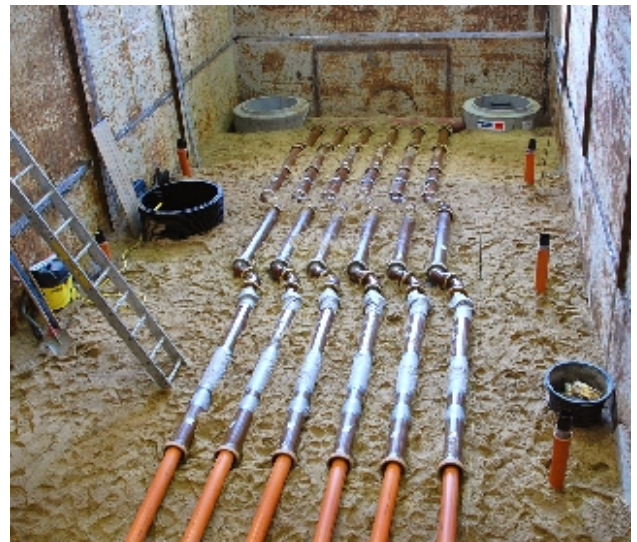
Lateral sewers including material changes, damage scenarios and bends being installed for evaluation of liners

An initial evaluation of lateral sewer lining systems against groundwater infiltration yielded an unexpected result – circumferential **cracking of the liners** at the location of host pipe joints. The cause was determined to be that the **products bonded too tightly** to the host pipe to be able to flex when pipe sections moved relative to each other due to floatation as groundwater levels rose. The industry made **modifications** based on these findings, and satisfactory results were obtained for products submitted in a subsequent evaluation.

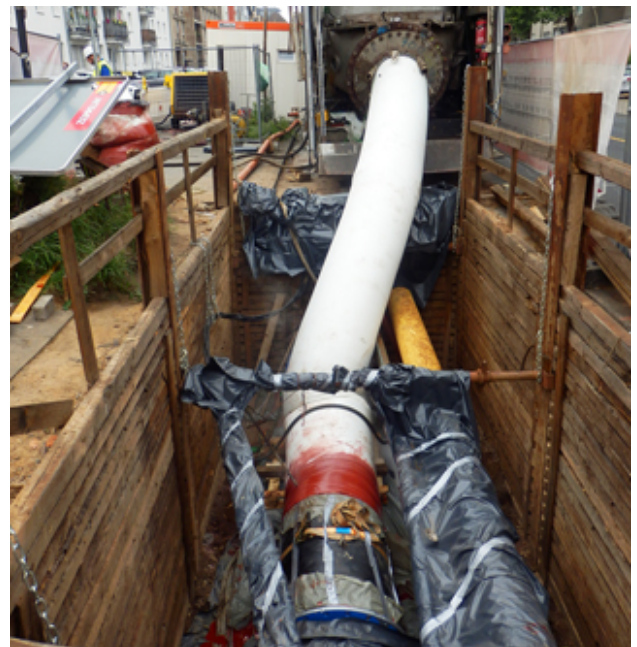
IKT Compare: testing lining systems for the trenchless rehabilitation of pressure sewers

Around the world sewer network owners are struggling to address the options for **replacement or rehabilitation** of ageing **pressure sewers**. Often the preferred solution is to dig them up and replace them. **Rehabilitation solutions** using trenchless technology tend to be used only when it is too difficult to excavate, but sewer network owners are interested in using such technology more often. First, they need to fully understand it.
