# IKT-LinerReport 2017: CIPP Liner Quality – The Need to Pass all Four Tests

# Large Diameter Pipes – Repair or Replace? Non-destructive Testing with the MAC System

Non-destructive testing in sewers using the MAC system provides dependable data for structural assessment and, where necessary, selection of a rehabilitation method.

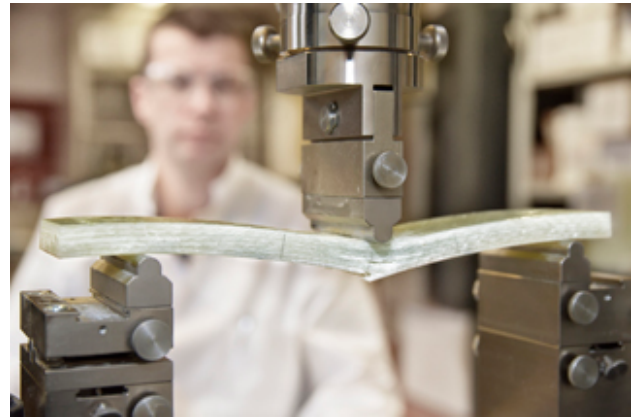
Under pressure: An IKT tester determines flexural strength at the point when a liner sample ruptures.

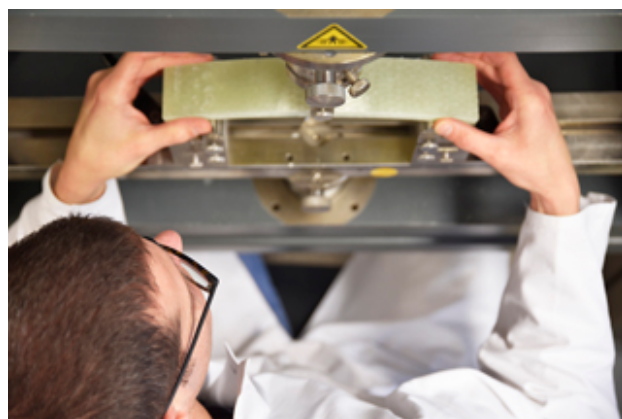
Modulus of elasticity and flexural strength: weaker results than for previous years

On average, **97.4%** of the liners reached their required modulus of elasticity. This result was **1.5% lower than 2016** and 1.7% lower than 2015, the year when the highest score was achieved in any of the previous IKT LinerReports. However, this does not necessarily indicate a trend. Fifteen out of the 25 rehabilitation companies in this year's survey achieved 100% for this test, one of them for two different liner systems.

previous years (-0.8% and -1.7%, respectively). Fourteen rehabilitation companies achieved a score of 100%, but the results were much more **broadly distributed**. The lowest-scoring company passed only 70% of the tests.

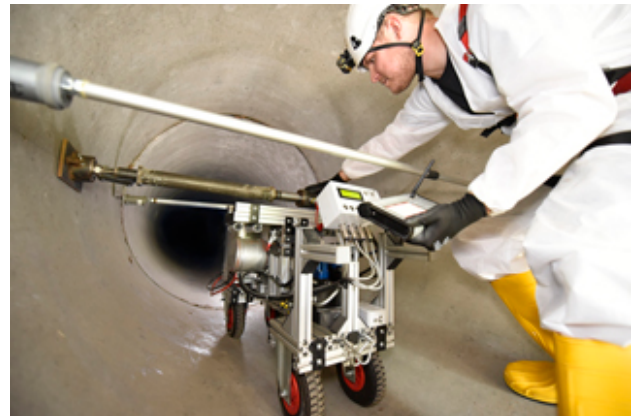
Investigate the pipe and surrounding soil using the MAC system: non-destructive testing of the stability of large-diameter sewers

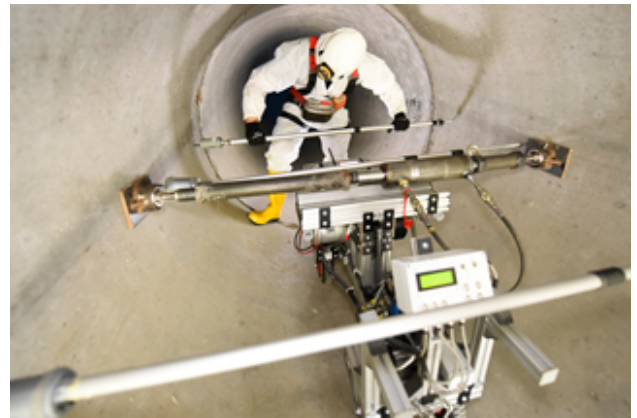
The MAC system is capable of accurately determining the condition of both the pipe and the embedment by non-destructive in-situ testing and subsequent calculations

There is a **method** which is capable of accurately determining the condition of both the pipe and the embedment by **non-destructive in-situ testing** and subsequent **calculations**. This is the **MAC (Mechanical Assessment of Conduits) system**, which was first developed by Eau de Paris, the water authority for the French capital. **IKT - Institute for Underground Infrastructure** has modified this system for use in smaller **diameters from DN 1000 upwards**, and then further developed and partially automated the control and instrumentation technology used.

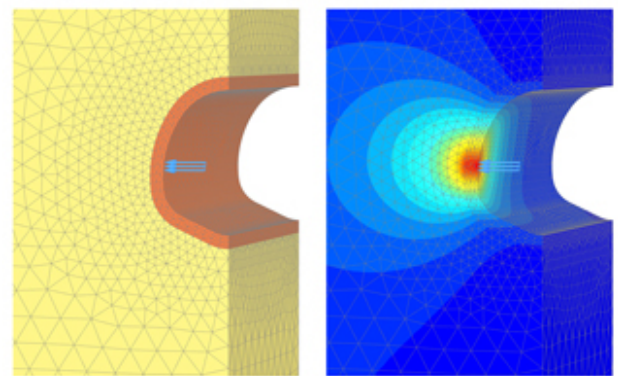
Discrete FE model of the sewer (orange) within the surrounding soil (yellow), showing application of load by the MAC unit (arrows) (left in figure) and resulting displacements in the sewer wall and soil, perpendicular to the axis of the sewer (qualitative) due to the load applied (right)

The tiny, localised deformations to the pipe wall that result are measured using position **sensors** and are entered into a **computer simulation**. A three-dimensional **Finite Element (FE) model** of the sewer, complete with the corresponding test data, is generated and the condition of the pipe and the bed is determined at each inspection point using sophisticated variation of parameters. The results provide **reliable input**

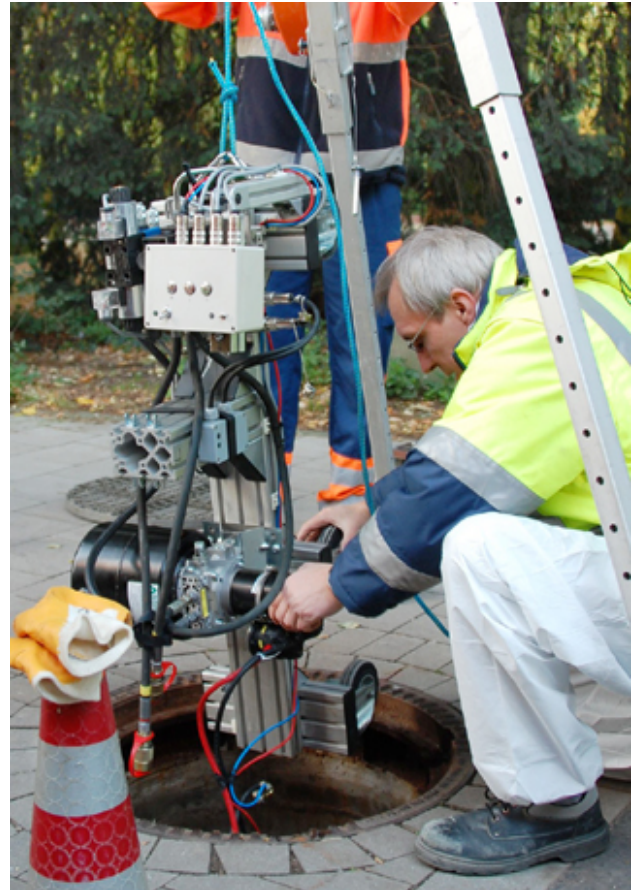
The MAC unit can be easily disassembled into modules, so it can be lowered into the sewer via a standard manhole shaft

The MAC unit can be easily disassembled into modules, so it can be lowered into the sewer via a standard manhole shaft. The system is then reassembled in the sewer ready for use.

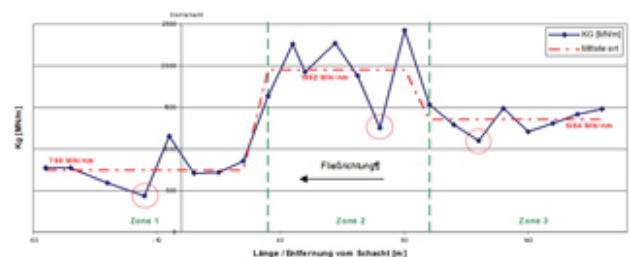
Results of a MAC inspection:  
graphical view of overall  
stiffnesses (KG) with  
subdivision into zones

Following the survey with the MAC unit the **overall stiffness** of the pipe-embedment system at the points of measurement is determined. The measured data can then be used for classification of the entire sewer length into **zones of identical pipe/soil stiffness**. Potential weak points can then be directly located and the locations that require **more detailed investigation** can be systematically specified.

The in-situ measurements provide the general reaction of the **pipe/soil system** to the pressure applied by the MAC unit. These figures are purely mathematical variables and are dependent on the test apparatus and the sewer structure. **Further analysis** is necessary to derive data which can be

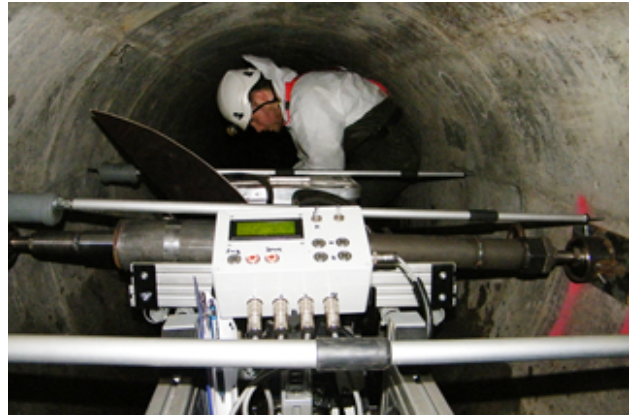
Deployment in Bournemouth,  
England

The MAC system exerts a **controlled force** on the pipe wall in the sewer using a hydraulic press to generate a **minimal ovalisation** of the sewer cross-section. The deformation allowed and the force applied are kept sufficiently small, by a precalculation, to **prevent any damage** to the sewer structure.

During the testing, a high-pressure cylinder is used to apply **sufficient force** to the walls, at specified intervals along the length, to move them under control a few **tenths of a millimetre** apart without causing damage to the sewer. Fine sensors measure the **resulting deformation** in the vicinity of the hydraulic ram and at distances of around one metre ahead and behind it. This very slight deformation is sufficient to permit derivation of the condition of the pipe and of the soil, on the basis of the deformation pattern and the force

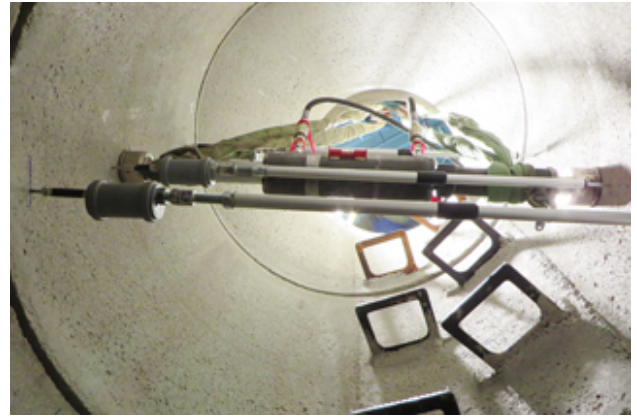
Manhole-shaft stability assessment: evaluations performed during IKT “manhole-shaft rehabilitation” product test show that manholes can also be inspected using the MAC system

Just as the MAC system works for inspecting old or new pipes, it can also be used whether they are installed horizontally or vertically. Consequently, **manhole stability** can also be inspected using the MAC system. This application has been refined by testing stability as part of IKT “**manhole-shaft coating**” **product testing**. During these, manhole shafts were inspected using the MAC system in new condition, in cracked and unrepaired states, and then following rehabilitation using various methods.

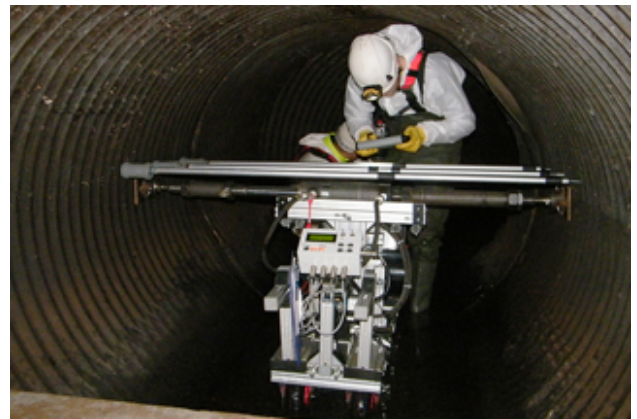
Deployment in Weston-super-Mare, England

The **MAC system**, on the other hand, makes it possible to “**look deeper**” into the pipe wall and beyond into the embedment, making it possible to detect more than simply weaknesses that are apparent on the surface.

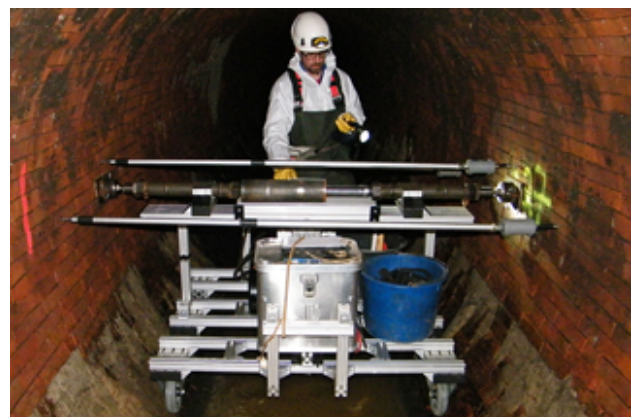
Deployment of the MAC system  
in Hamburg, Germany

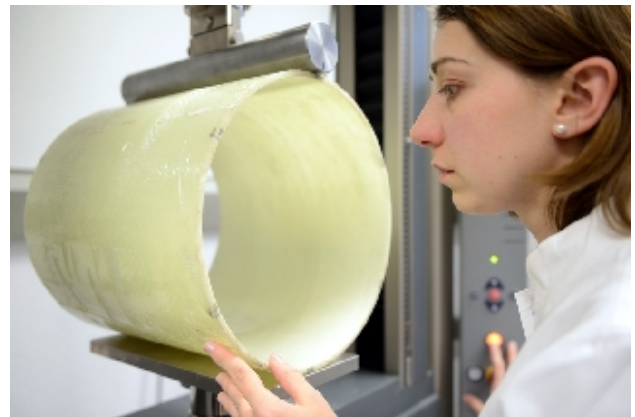
Major topic: CIPP and quality control – crown pressure test on a CIPP liner

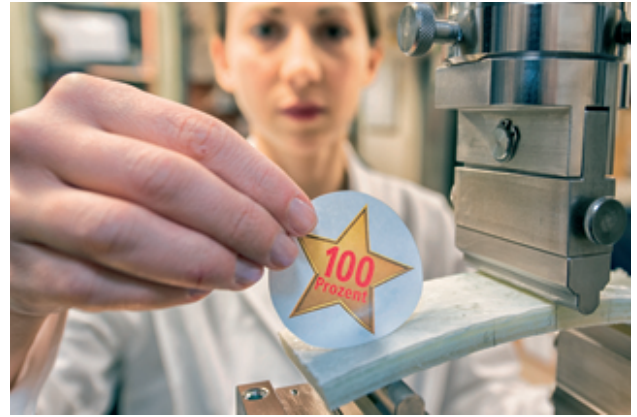
Three-point bending test on CIPP liners

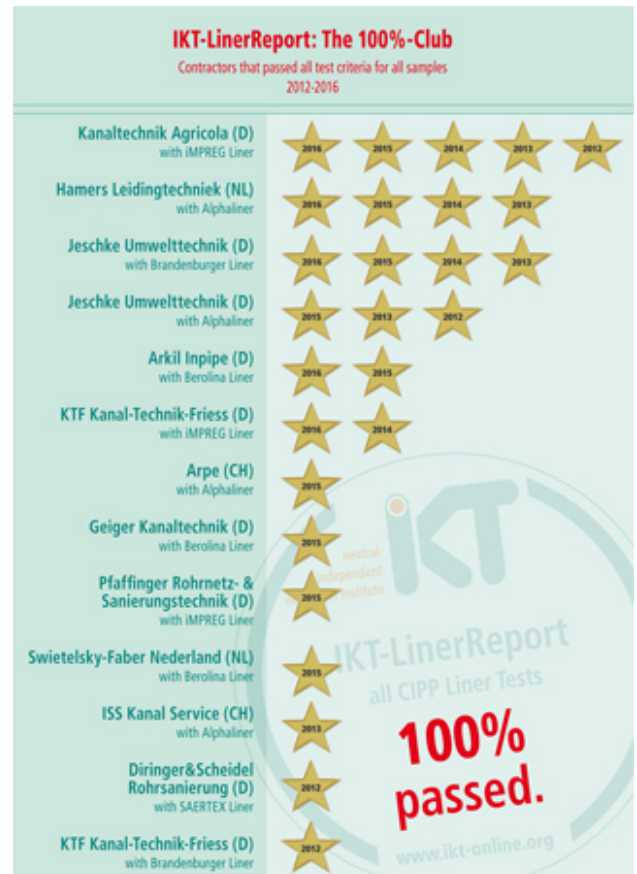
The 100%-Club: Contractors that passed all test criteria for all samples in one year (2012-2016)

In the past five years, in particular, it has become apparent that a number of rehabilitation contractors achieve **optimum performance**. These companies meet all four test criteria with all their liner samples and thus constitute what we are calling the **“100% Club”**. Therefore, they are entirely **fulfilling the requirements** of the German “ZTV Material Test” (Supplementary Technical Contractual Conditions) and the **expectations of their customers**. Only five of the twenty-two companies are included in this Club in 2016 (in 2015 it was 9 of 24), and only few contractors maintain such high performance over several years.
