IKT LinerReport 2018: Has Trend for Improving Quality Ended?

For more than ten years, the performance of CIPP liners continuously improved. But, in recent years the annual test results have sometimes been poorer. Is this a sign of a reversal in that trend?

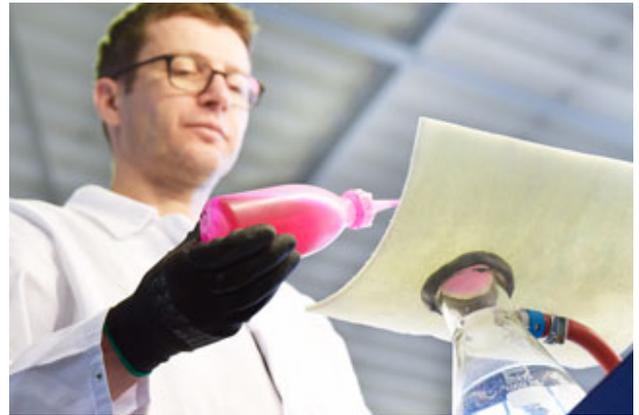
Watertight or not? Water tightness testing in the IKT laboratory

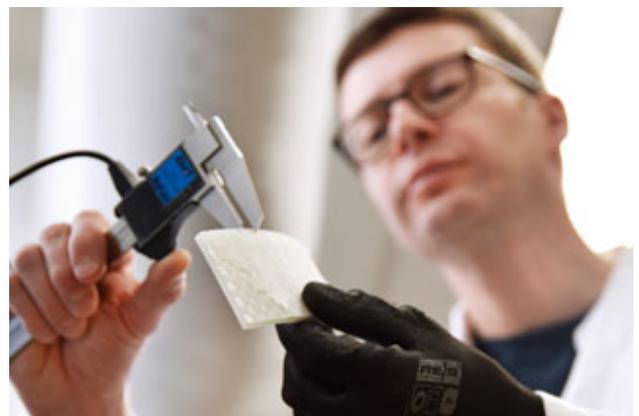
Wall thickness measurement: requires particularly high precision

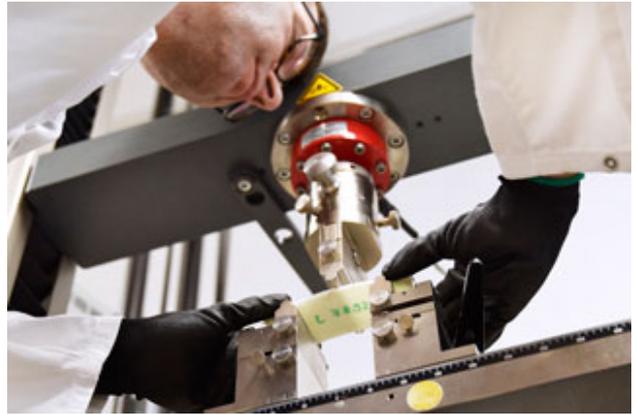
Three-point bending test: mechanical testing of modulus of elasticity and bending strength
