# IKT LinerReport 2018: Has trend for improving quality ended?

For more than ten years, the performance of CIPP liners continuously improved. But, in recent years the annual test results have sometimes been poorer. Is this a sign of a reversal in that trend?

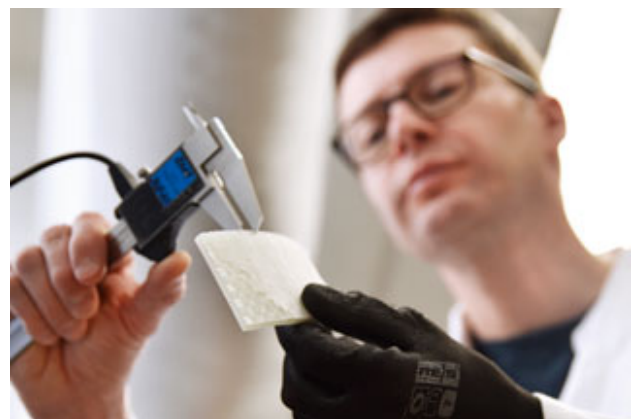
Wall thickness measurement: requires particularly high precision
