# IKT LinerReport 2018: Has Trend for Improving Quality Ended?

For more than ten years, the performance of CIPP liners continuously improved. But, in recent years the annual test results have sometimes been poorer. Is this a sign of a reversal in that trend?

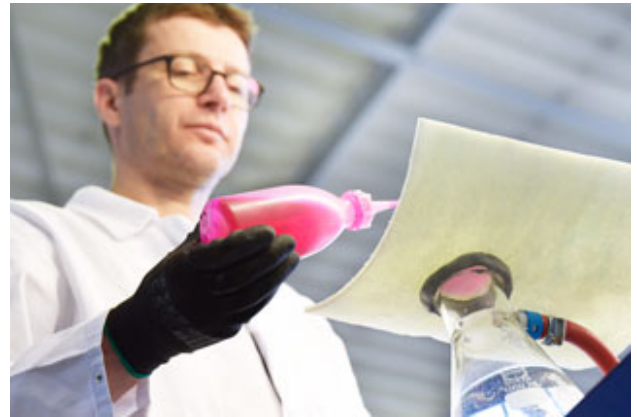
Watertight or not? Water tightness testing in the IKT laboratory

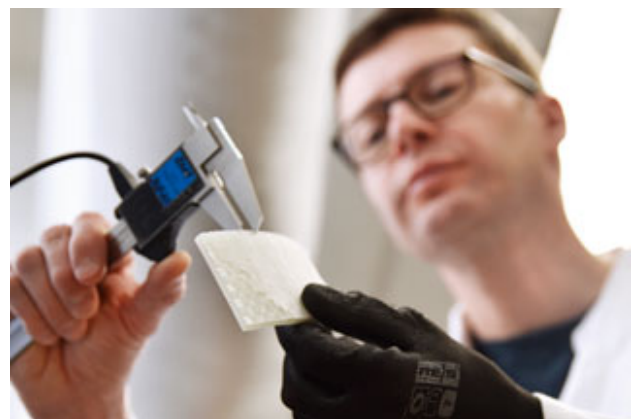
Wall thickness measurement: requires particularly high precision

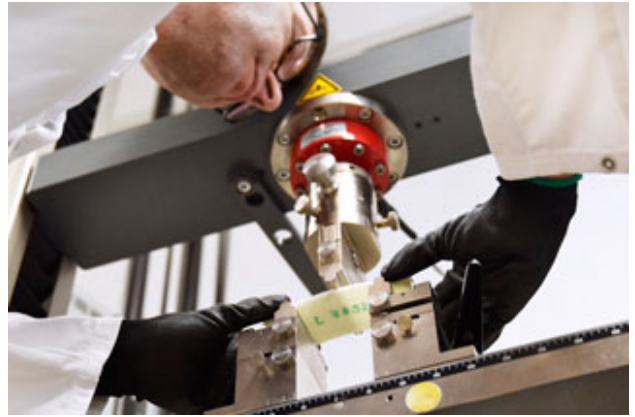
Three-point bending test: mechanical testing of modulus of elasticity and bending strength
