Two-Meter CIPP Giant, Zero Downtime: UV-Cured GRP Relines Main Collector in Belgium

First in Belgium: a DN 2000 sewer collector that can't stop for a second is being rehabilitated with UV-cured GRP liners. The unique twist? They have to keep a whole city running with a bypass of 13,000 m³/h while crews worked just before the treatment plant. To show how that's engineered, international experts were invited on site. Amongst them: IKT's Ashwini Ausekar, who shares insights from her site visit.

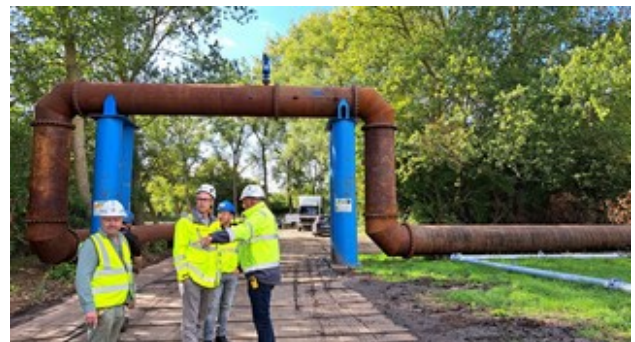
Bypass of 13,000 m³/h: Pumping stations and pressure sewer pipes to divert the flow from the rehabilitation stretch to ensure continues flow towards WWTP

To guarantee continued wastewater transport during the works, a temporary bypass pumping system was installed, capable of **diverting up to 13,000 m³/hour** to the treatment plant. This ensured uninterrupted operations while rehabilitation proceeded in 60-hour continuous shifts.

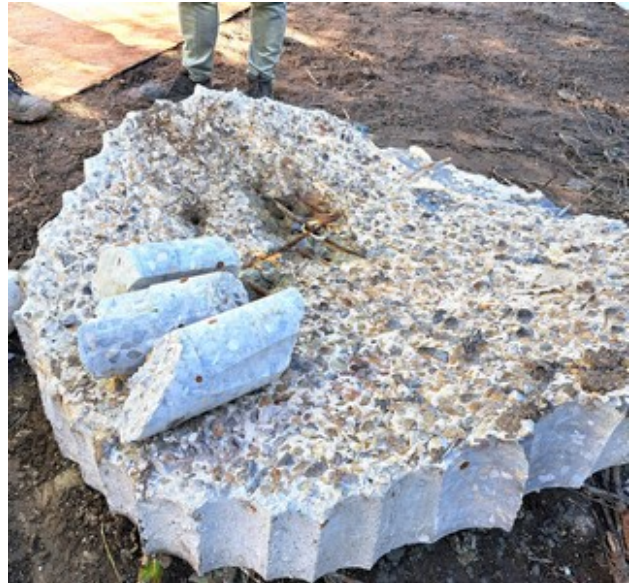
Extracted piece of host reinforced concrete pipe shows corrosion with coarse aggregates and dissolved reinforcement bars.

Inspection revealed that the reinforced concrete host pipes, originally 19 cm thick, had in some places been reduced to as little as 2 cm due to severe corrosion **caused by hydrogen sulfide (H₂S)**. In certain sections, reinforcement steel had already dissolved. Without intervention, the risk of sewer collapse and subsequent sinkholes would have been high, with major social, ecological, and economic consequences.

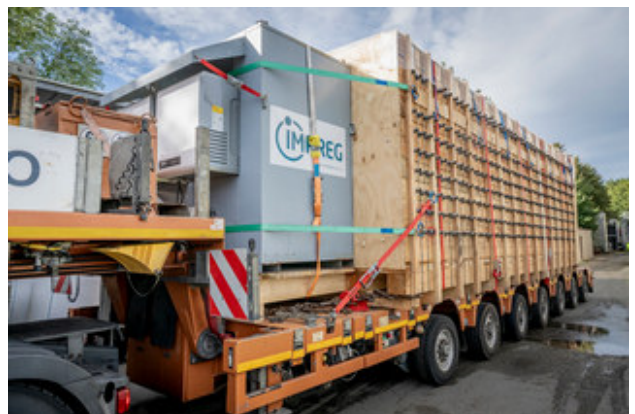
100 tonnes on the way: the DN

2000 large CIPP liner from Impreg

This remarkable rehabilitation covers a total length of 156 meters, installed with a pull-in method and cured using 36 kW UV lamps progressing at approximately 45 cm per minute. The GRP liners, supplied by Impreg, were transported to site with a total weight of 100 tons.
