# IKT-LinerReport 2017: CIPP Liner Quality – The Need to Pass all Four Tests

# Large Diameter Pipes – Repair or Replace? Non-destructive Testing with the MAC System

# **Five Major Topics for Further Action Identified by IKT's New International Contact Group on Sewerage Issues**

# **IKT-LinerReport 2016: Five Companies Qualify for the '100% Club'**

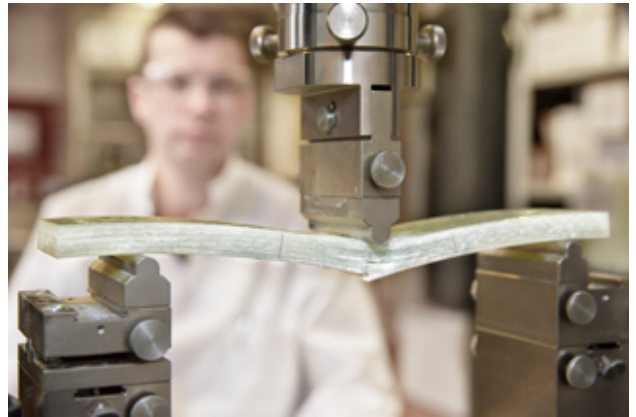
Under pressure: An IKT tester determines flexural strength at the point when a liner sample ruptures.

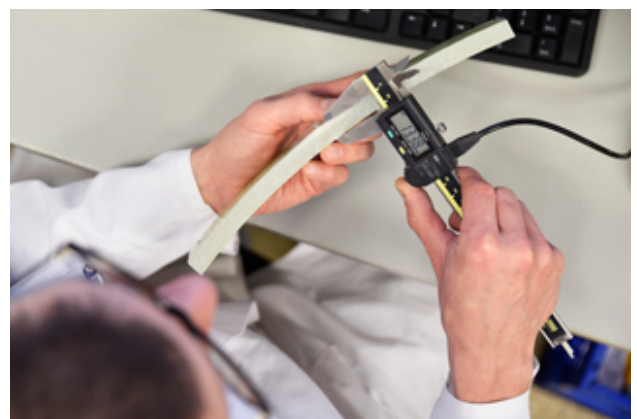
Wall thickness: wide distribution of results with lowest-scoring company passing only 60% of the tests

On average, the results of the wall thickness test were **lower** than for the two previous years: -1.7% compared to 2016 and -0.9% compared to 2015. The **distribution of results** for wall thickness was much greater than for the modulus of elasticity and flexural strength, with the lowest-scoring company passing 60% of the tests.

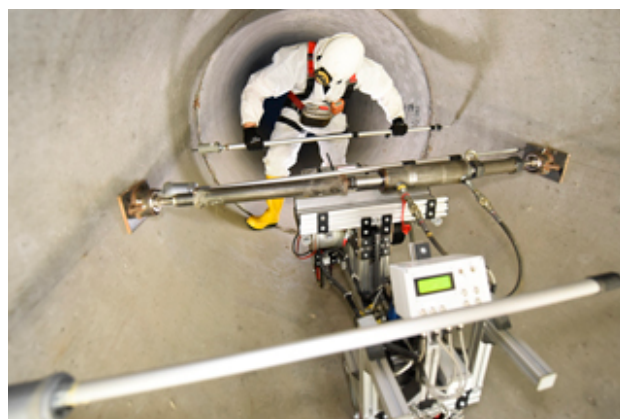
The MAC system is capable of accurately determining the condition of both the pipe and the embedment by non-destructive in-situ testing and subsequent calculations

There is a **method** which is capable of accurately determining the condition of both the pipe and the embedment by **non-destructive in-situ testing** and subsequent **calculations**. This is the **MAC (Mechanical Assessment of Conduits) system**, which was first developed by Eau de Paris, the water authority for the French capital. **IKT - Institute for Underground Infrastructure** has modified this system for use in smaller **diameters from DN 1000 upwards**, and then further developed and partially automated the control and instrumentation technology used.

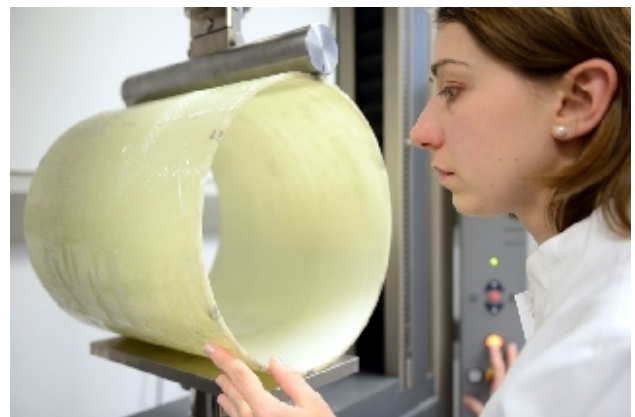
Major topic: CIPP and quality control – crown pressure test on a CIPP liner
