# Two-Meter CIPP Giant, Zero Downtime: UV-Cured GRP Relines Main Collector in Belgium

First in Belgium: a DN 2000 sewer collector that can't stop for a second is being rehabilitated with UV-cured GRP liners. The unique twist? They have to keep a whole city running with a bypass of 13,000 m<sup>3</sup>/h while crews worked just before the treatment plant. To show how that's engineered, international experts were invited on site. Amongst them: IKT's Ashwini Ausekar, who shares insights from her site visit.

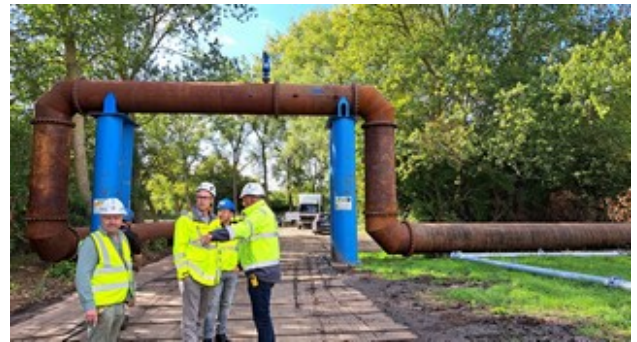
Bypass of 13,000 m<sup>3</sup>/h: Pumping stations and pressure sewer pipes to divert the flow from the rehabilitation stretch to ensure continues flow towards WWTP

To guarantee continued wastewater transport during the works, a temporary bypass pumping system was installed, capable of **diverting up to 13,000 m<sup>3</sup>/hour** to the treatment plant. This ensured uninterrupted operations while rehabilitation proceeded in 60-hour continuous shifts.
