# Testing assignment: IKT puts pressure on manhole lining

**Leaks cannot be tolerated! So manholes in high water table areas must reliably keep any groundwater out. They need rehabilitating if they no longer do this. There are numerous methods to choose from.**

Schacht + Trumme W. Schwarz GmbH, of Ahrensburg Germany, wanted to know whether their HDPE manhole lining would withstand continuous exposure to external water pressure, so they commissioned a test by IKT. The lining was installed into a systematically „pre-damaged“ manhole structure consisting of prefabricated concrete elements in IKT's large-scale test facility.

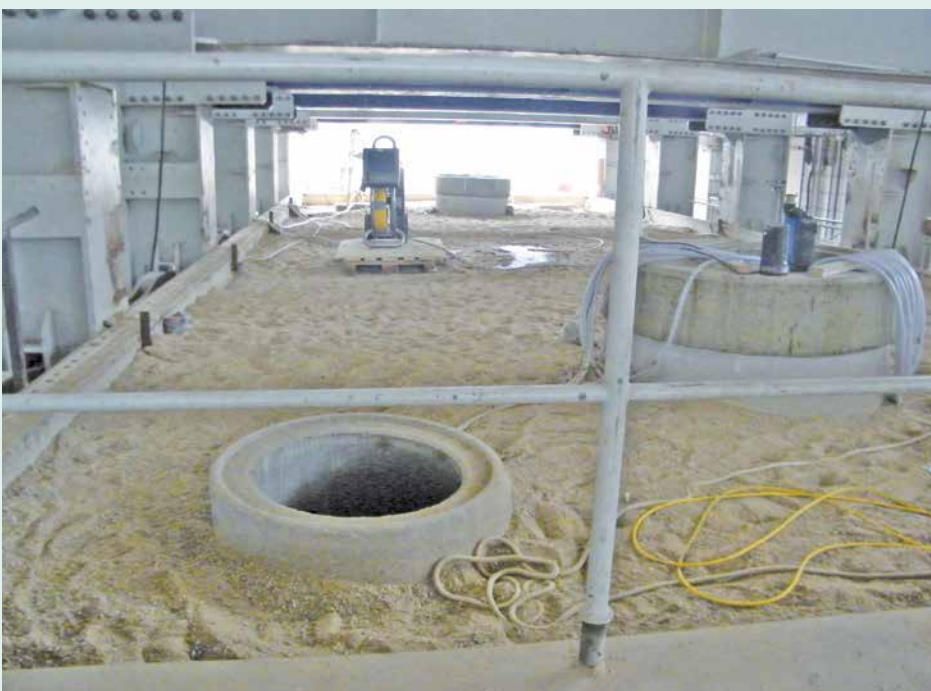
A giant sandpit: IKT's 6 m deep large-scale test facility can be flooded.

The client's rehabilitating team installed the around 3 m high partial lining in the 5.5 m deep manhole shaft with no pre-sealing of the „implanted“ points of damage. One day later, the large-scale test facility was flooded to a depth of two metres above the bottom sheet of the lining. This water level was kept constant for nearly four months, and then increased in increments to 4.5 m. This raised external water pressure was then maintained for another two months.

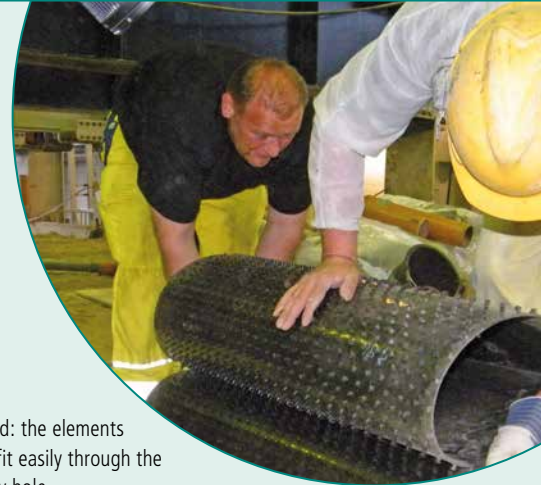
Cleverly folded: the elements of this lining fit easily through the manhole entry hole.

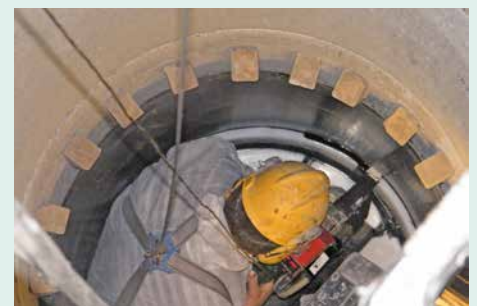
The joints between the individual elements are carefully sealed.

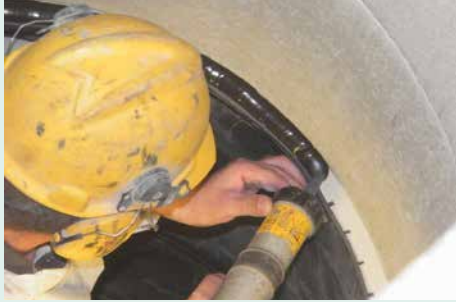
The annular space between the manhole shaft and the lining is firstly grouted using mortar, and then sealed.

The bond strength of the PE lining and the grouting mortar with the wall of the manhole shaft was on average 0.4 N/mm<sup>2</sup> across various testing points.
